Technical Service Bulletin

94 Daytime Running Light (DRL) inoperative

94 13 21 2032184/2 July 9, 2013. Supersedes Technical Service Bulletin Group 94 number 13-05 dated February 8, 2013 for reasons listed below.

Model(s)	Year	VIN Range	Vehicle-Specific Equipment
Q5	2013 - 2014	All	Audi Xenon Plus with LED Daytime Running Lights

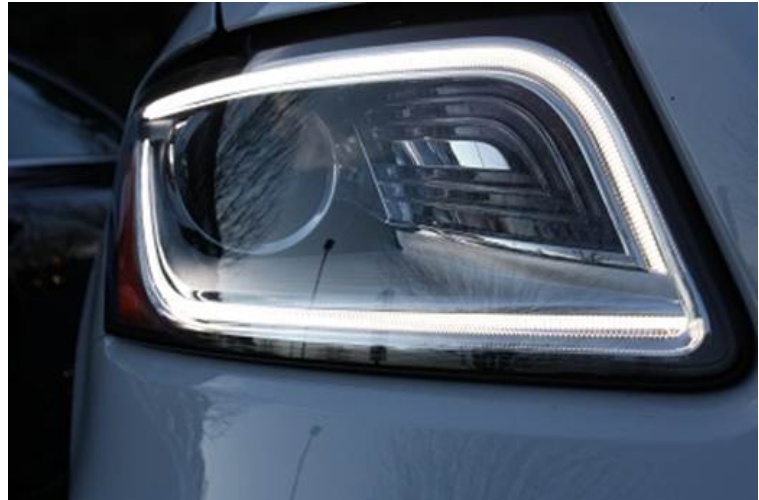
The MY2013+ Audi Q5 LED DRLs use light-emitting “pipes” instead of multiple, individual LEDs. There are two light pipes per headlight. Each light pipe uses a single LED for illumination (Figure 1).

Figure 1. Upper and Lower light pipe illuminated.

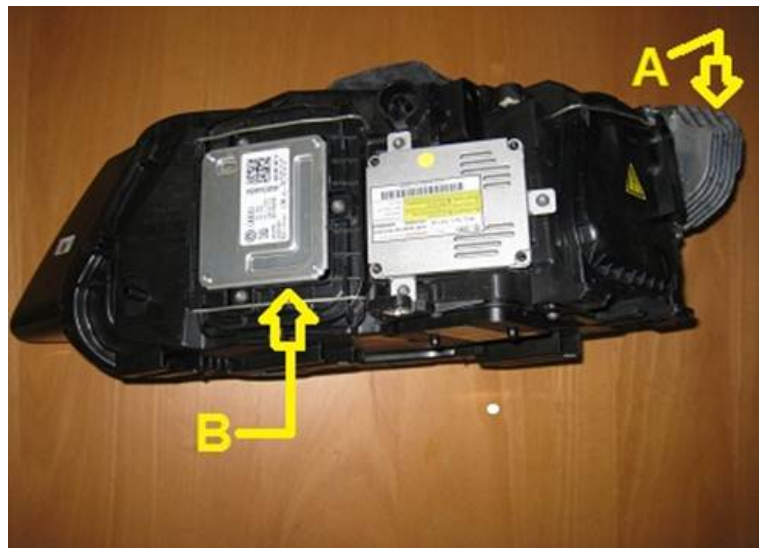
The LED unit with heat sink utilizes a gasket and is keyed into the headlight housing to maintain proper alignment of the LED to each light pipe. The LED units (L176 and L177, left and right, respectively) are controlled via a control module (J860 and J861, left and right, respectively) located separately on the backside of the headlight (Figure 2). These LED units and LED control modules are electrically interchangeable from side to side, but the LED units are mechanically specific to each headlight side.

Figure 2. Backside of headlight with LED heat sink (A) and LED control module (B).

1. With ignition off, remove DRL control module and check red connector at module. Secure it, if loose. If necessary, remove red connector and reinstall to be sure connector is engaged properly. The wire guide of the red terminal housing may impede connector engagement.
2. Turn ignition on to see if DRL is now operating to specifications. If it is not, proceed to step 3.
3. Remove headlight(s) according to the instructions in ElsaWeb. See *Repair Manual* >> *Electrical System* >> *Electrical Equipment* >> *94 Exterior Lights, Switches* >> *Removal and Installation*.
4. With ignition off, remove LED DRL unit with heat sink from headlight housing (Figure 6).

5. With ignition off, inspect and secure all electrical connectors, if loose. Remove and secure the white connectors, even if they do not appear to be loose.
