SUBJECT: **Regional Program 13R01**

Certain 2005 Through 2011 Model Year Crown Victoria, Grand Marquis, and Town Car Vehicles Not Covered Under Safety Recall 13S08
Steering Column Shaft

REF: **Safety Recall 13S08**

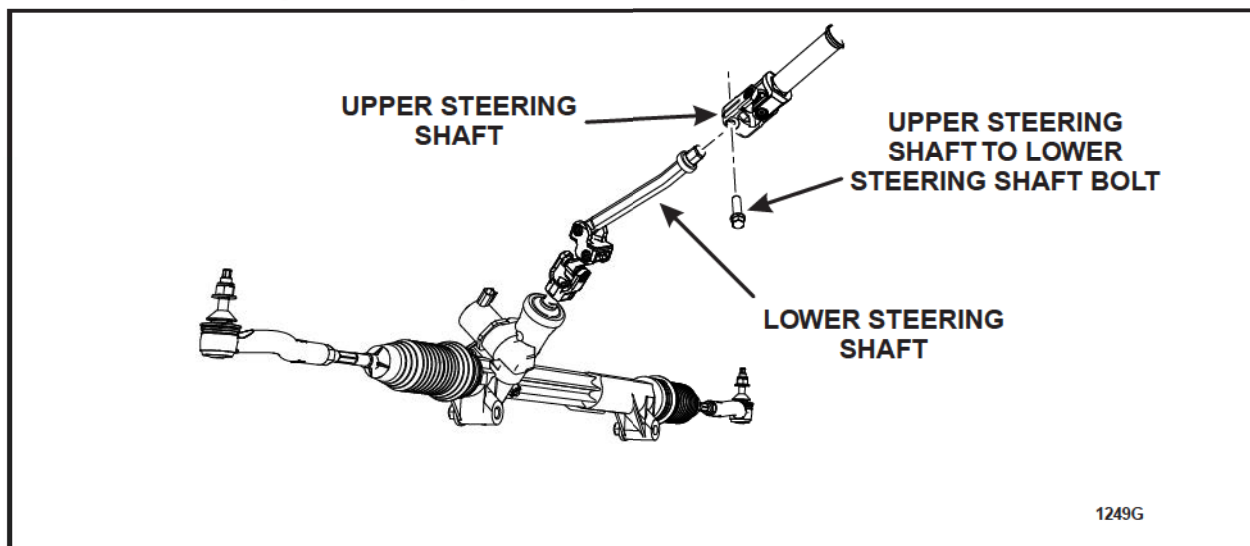
FIGURE 1

1. Inspect the lower steering shaft joints for binding or seizure, as follows:
 - a. Use a steering wheel holding device (such as Hunter® 28-75-1 or equivalent) to hold the steering wheel in the straight-ahead position.
 - b. Remove and discard the upper steering shaft to lower steering shaft bolt and disconnect the lower steering shaft. See Figure 1.

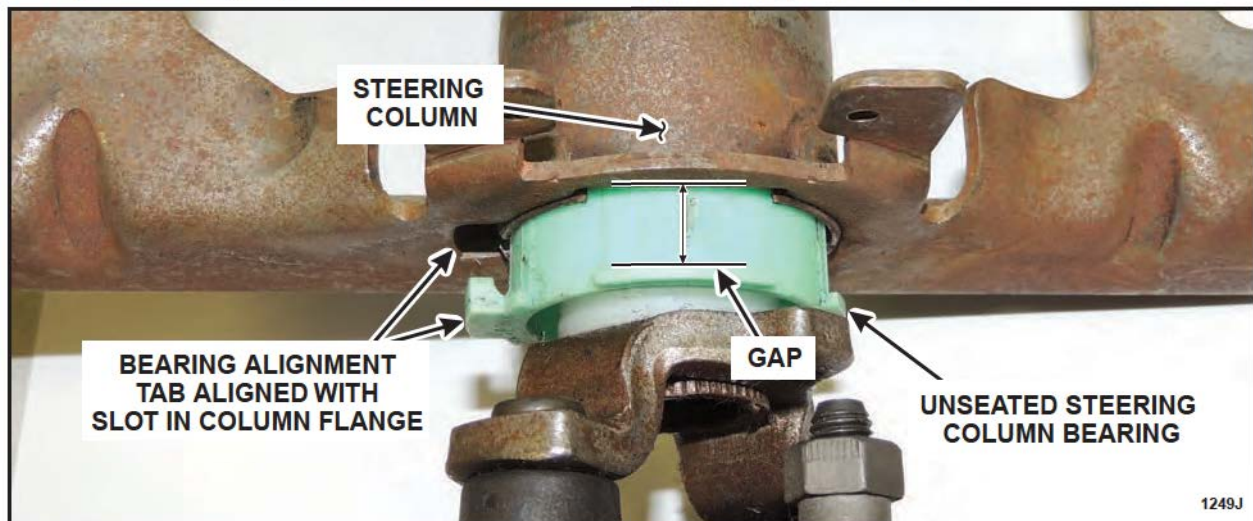
FIGURE 8

NOTE: In some instances the steering column bearing orientation tab may have broken off. If the tab has broken off, the bearing is still usable and can be seated within the steering column in any orientation.

2. Align the bearing alignment tab with the slot in the column flange. See Figure 8.
