GROUP Fuel System	MODEL 2011-2013MY Optima w/2.0L & 2.4L GDI (QF/TF) 2011-2013MY Sportage w/2.0L GDI (SL) 2012-2014MY Sorento w/2.4 GDI (XM) 2014MY Sorento w/3.3L GDI (XM) 2014MY Cadenza w/3.3L GDI (VG)
	NUMBER 026	DATE September 2013

TECHNICAL SERVICE BULLETIN

SUBJECT: MIL ON WITH DTC P0087 - DIAGNOSIS AND REPAIR

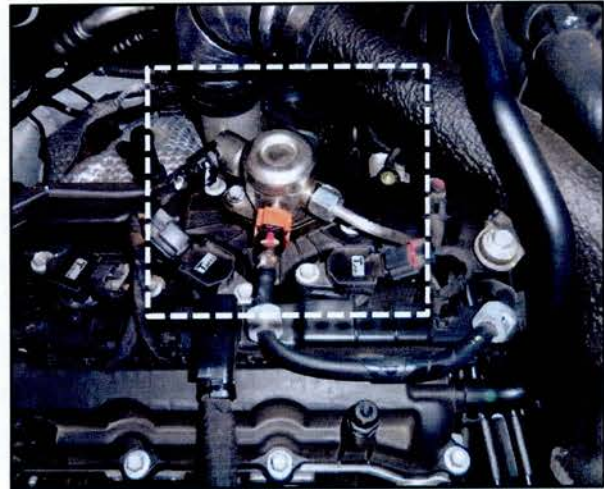
To avoid a possible fuel leaks, do **not** reuse the high pressure fuel delivery pipe.

1. Replace the high pressure fuel pump per applicable procedure on KGIS.

Refer to TSB ENG 083 for more details on GDI high pressure system handling procedures and fuel pump replacement, and the need to replace additional (one time use) hardware when the high pressure fuel pump is replaced.
