NEWMAR CORPORATION WARRANTY DEPARTMENT

TECHNICAL SERVICE BULLETIN																	
DATE ISSUED	MODEL YEAR(S) AFFECTED		MODEL(S) AFFECTED			TSB #											
10/11/2013	2013 & 2014		King Aire, Essex & Mountain Aire			407											
BRAND						TYPE											
All	<input type="checkbox"/>	American Star	<input type="checkbox"/>	Mountain Aire	<input checked="" type="checkbox"/>	All	<input type="checkbox"/> TT <input type="checkbox"/>										
Cypress	<input type="checkbox"/>	Dutch Star	<input type="checkbox"/>	Kountry Aire	<input type="checkbox"/>	FW	<input type="checkbox"/> CA <input type="checkbox"/>										
Northern Star	<input type="checkbox"/>	Kountry Star	<input type="checkbox"/>	Essex	<input checked="" type="checkbox"/>	DP	<input checked="" type="checkbox"/> DB <input checked="" type="checkbox"/>										
Scottsdale	<input type="checkbox"/>	King Aire	<input checked="" type="checkbox"/>	London Aire	<input type="checkbox"/>												
All Star ME	<input type="checkbox"/>	Ventana	<input type="checkbox"/>	Bay Star	<input type="checkbox"/>

G-2000/NOVA AWNING (ECO) ENGINEERING CHANGE ORDER

12 Volt Motion Sensor Upgrade Announcement

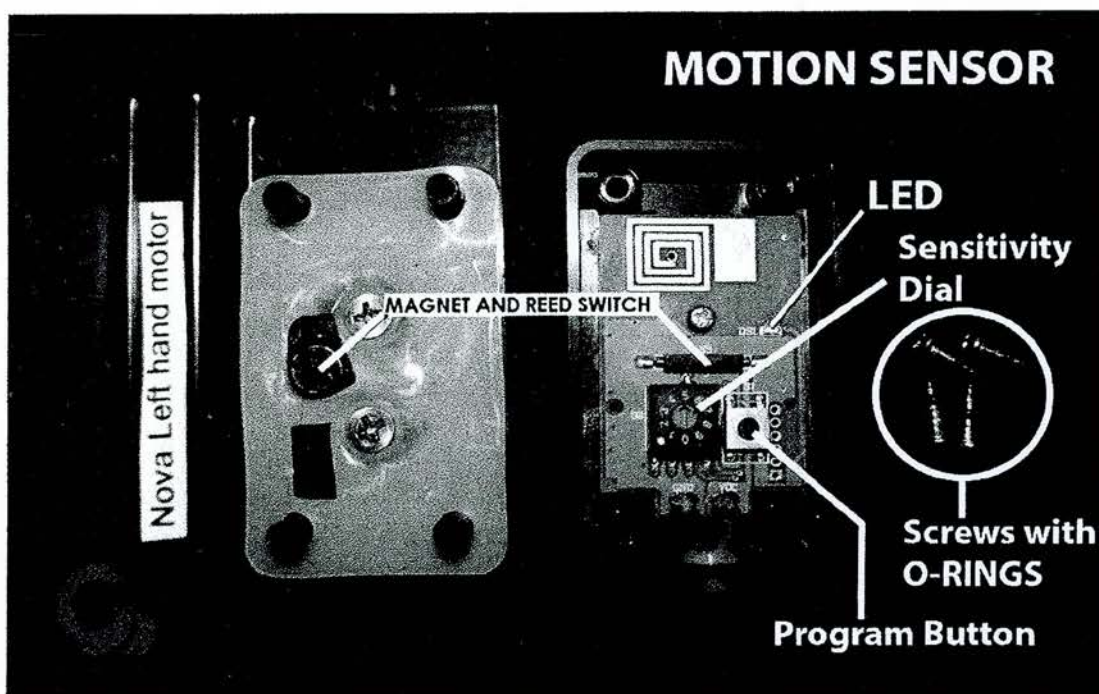
Figure 3

NOTE: THE O-RINGS ARE A CRITICAL PART OF THE NEW MOTION SENSOR AND MUST BE USED (Figure 3).

- C. Locate the Sensitivity Dial and carefully adjust to the **#5** Position (Figure 3).
- D. Place the Motion Sensor cover upside down and back onto the base (Figure 4). The reed switch must be located directly over the magnet to operate the Motion Sensor.
- E. Apply a 12V Power Source to the 12V Motion Sensor. The Purple LED will turn on solid and then will flash intermittently. The Motion Sensor is now ready to program.
NOTE: IF THERE IS NO POWER TO THE 12V MOTION SENSOR IT WILL NOT TRANSMIT THE PROGRAMMING.
- F. Using a small screwdriver or end of a paper clip press the **Program Button** on the GC136 Controller. The Green LED on the GC136 Controller will begin to flash.
- G. Press the **Stop Button** on the GC136 Controller. The Green LED on the GC136 Controller will turn solid.

- H. Press the **Program Button** on the Motion Sensor. The Purple LED will turn on while it is pressed.
- I. Test the programming by pressing the **Program Button** on the Motion Sensor (Figure 3). The awning should retract. If the awning does not retract, please repeat steps "E" through "I" in this section.
- J. Once the programming has been verified, press the **STOP Button** to stop the awning from retracting. The awning will need to be extended position to install the 12V Wire Harness Upgrade. Instructions located on Girard Systems 12V Motion Sensor Wire Harness Upgrade Kit CD and Manual.
- K. Remove the 12V Power Source from the Motion Sensor. Return the sensitivity dial on the motion sensor to the **#3** Position. Replace cover with four (4) screws including O-Rings.

- B. Remove the four (4) screws that retain the Motion Sensor cover. These screws will have an O-Ring attached.
NOTE: THE O-RINGS ARE A CRITICAL PART OF THE NEW MOTION SENSOR AND MUST BE USED (FIGURE 3).
