SERVICE BULLETIN

APPLICABILITY: 2012 - 13MY Impreza Models with 2.0L FB Engines
2013MY XV Crosstrek

NUMBER: 02-145-13R
DATE: 09/25/13
REVISED: 10/10/13

SUBJECT: Surface Treatment Change To Oil Control
Piston Rings

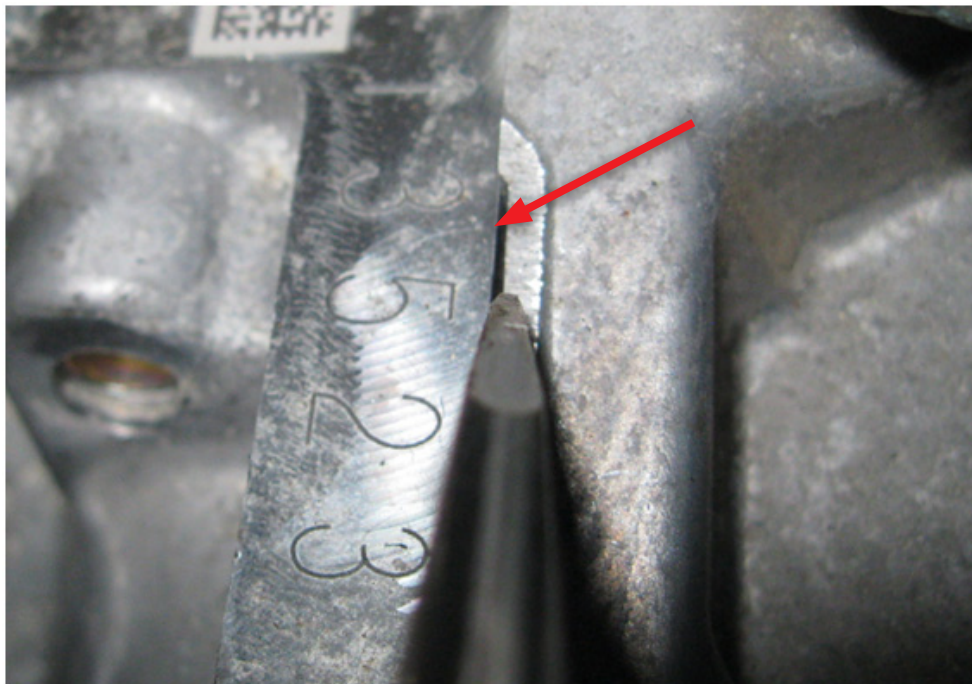
- To make separating the transmission (CVT) from the engine easier, there is a pry relief shown below in the machined mounting surface of the transmission case near the engine number. Use caution when applying any prying pressure and avoid twisting the tool to prevent case damage.

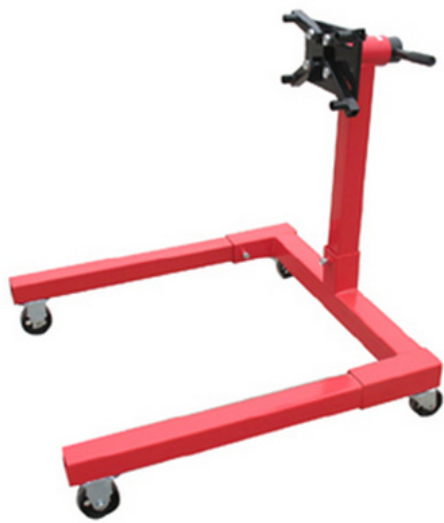
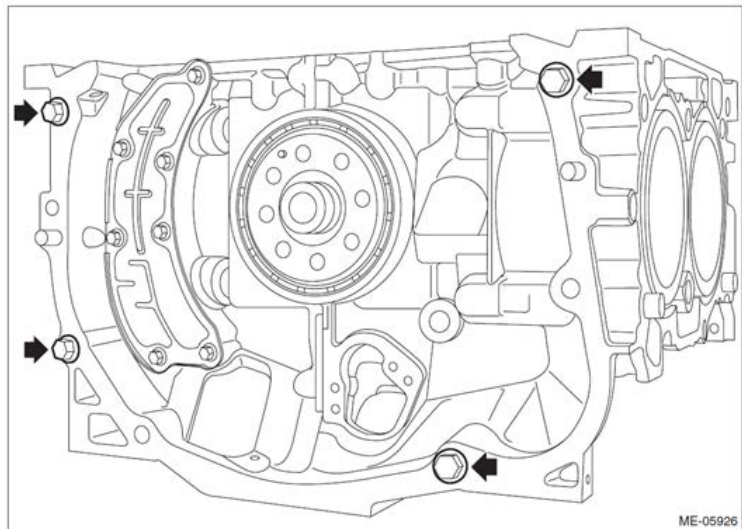
- Once the engine is removed, if you are using a generic engine stand (preferable since engine rotation is necessary), use the four mounting holes on the engine block shown below to mount it. Do not use the studs in the upper oil pan as the upper oil pan has to be removed to access the connecting rod bolts. **NOTE:** The connecting rod bolts are one-time-use and must be replaced.

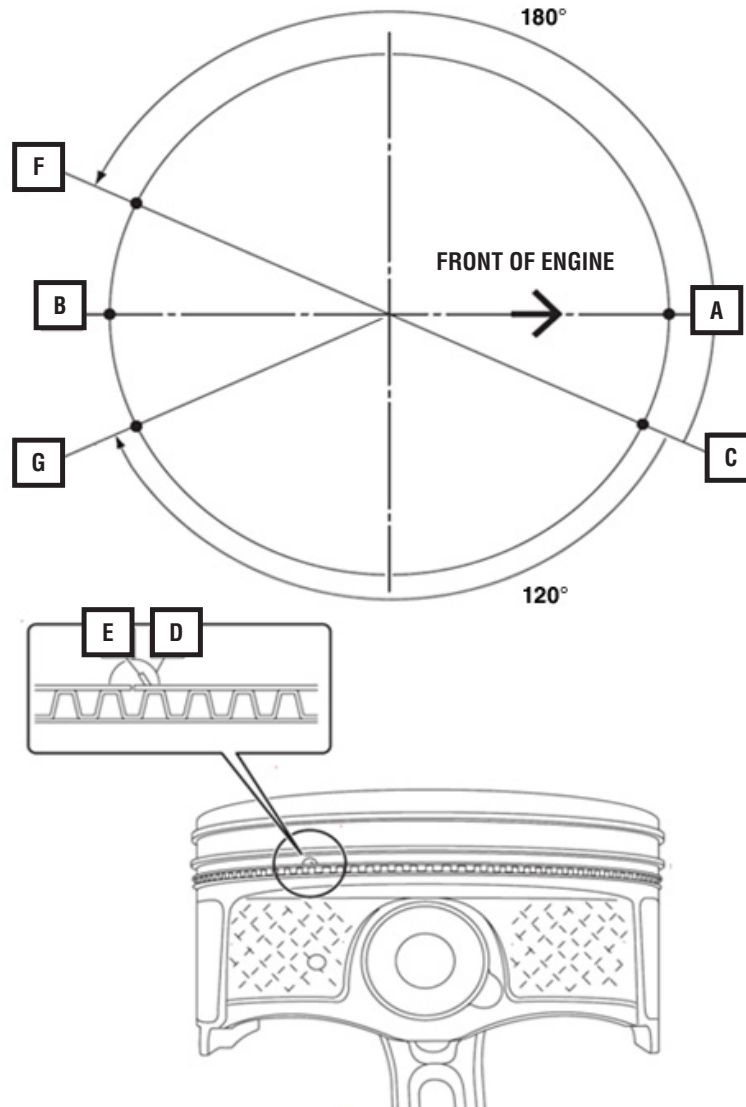
- “A”- Top compression ring end gap location
- “B”- Second compression ring end gap location (180 degrees away from “A”)
- “C”- Top oil control scraper ring end gap
- “D”- Recess in top of ring land to accept the “tang” of the upper oil control scraper ring - “E”
- “F”- Expander gap (180 degrees away from “C”)
- “G”- Bottom oil control scraper ring end gap (120 degrees away from “C”)

- When cleaning the pistons prior to installing the new rings, take care not to damage the anti-friction coating applied to the skirts. A mild parts cleaner may also be used with the Scotch-Brite Ultra-Fine #7448 (gray in color) to loosen and remove carbon deposits from the piston crown and from between the ring lands. Do not use Scotch-Brite to clean the piston skirts as it can damage the anti-friction coating. The ends of a removed compression ring may be used to carefully clean deposits from inside the ring lands. Rinse the piston / rod assemblies thoroughly and dry before installing the new rings onto the pistons. Refer to the Service Manual and the illustrations below for ring direction (marks facing upward) and end gap placements. Remember to lubricate the rings, piston skirts, cylinder walls, wrist pin areas, rod bearing surfaces and rod bolt heads and threads with engine oil before reassembly.
