## **Vehicle Owner Notification**

**Subject:** VON # 84 SAF-T-Liner HDX Turbo Coolant Line Replacement.

**Date:** 09/20/2013

## Subject: Saf-T-Liner HDX 90 degree elbow and fitting replacement

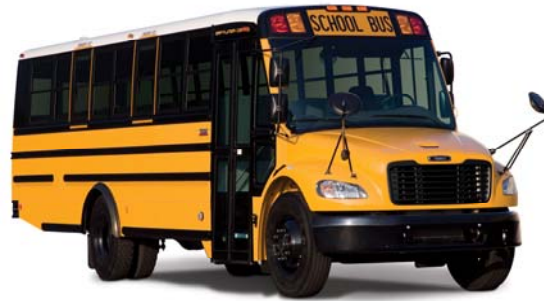
3) Locate the elbow that is located near the turbo on the Cummins CNG engine. It will have a Constant torque clamp on each end and then there will be one on other side of fitting. Loosen the one at the entrance to engine and the one that is on other side of fitting using a 5/16 socket. Remove and discard fitting, (Elbow hose if installing new one) and all three constant torque clamps. (See Figure 1 for location of clamps and which ones to loosen and discard)
