Topic	RE13/14 Carbon ceramic brakes Continental family
Market area	Worldwide Bentley (1WBE)
Brand	Bentley
Transaction No.	2030329/1
Campaign number	R790
Note	
Type	Recall campaign
US code

Recall campaign R790

RE13/14 Carbon ceramic brakes Continental family

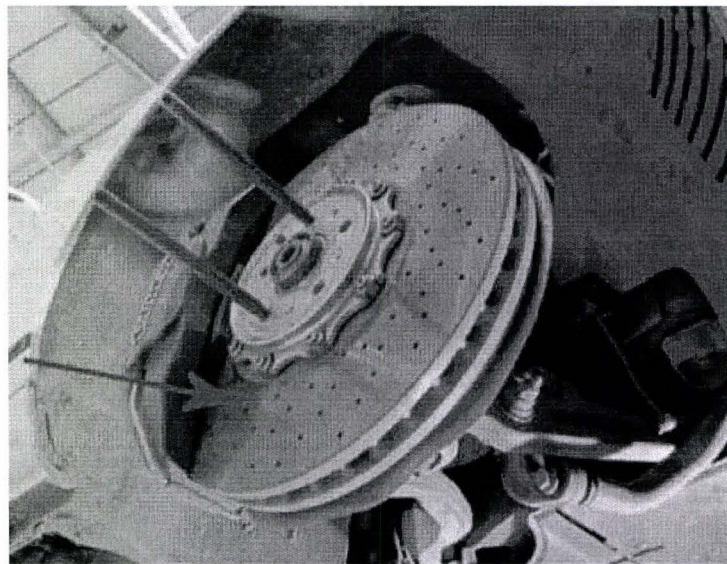
Due to the production process, relaxation cracks already exist on the friction surface of the brake disc when it is new. These cracks can vary in size and can occur on both sides of the disc.

Relaxation cracks on a ceramic brake disc do not constitute a technical problem.

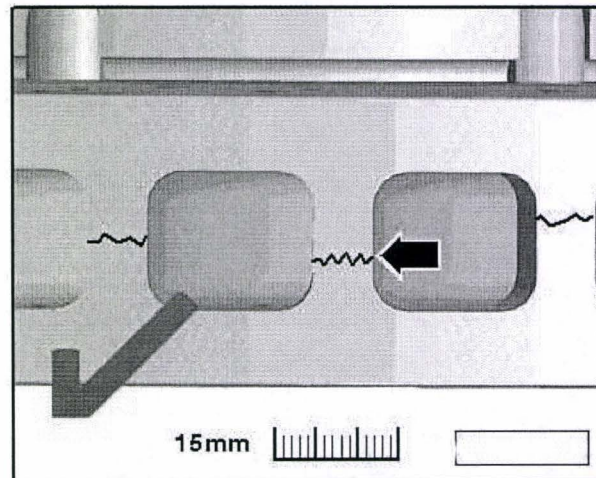
Cracks in the cooling channel lands -arrow- are caused during manufacture.

Cracks in the cooling channel lands do not constitute a technical problem.

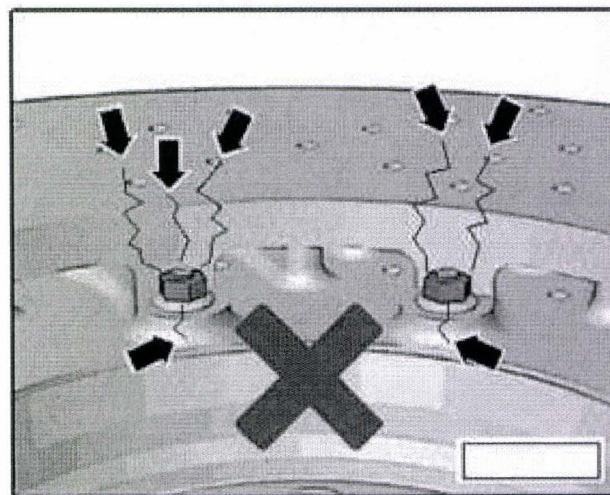
Edge fractures - arrow- are caused by mechanical

damage to the edges of the disc.

- Max. width / depth = 2 mm
- Max. length = 10 mm
- Max. 3 edge fractures per brake disc

If any of the criteria listed above are exceeded, the brake disc must be replaced.

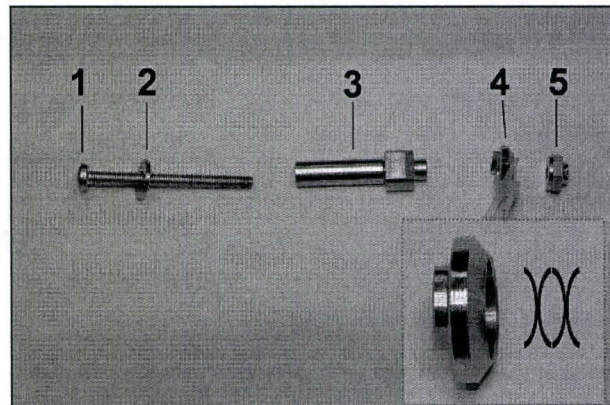
On the rear axle of vehicles fitted with carbon ceramic (CSiC) brakes, the stainless steel screws fixing the rotor to the metal bell may fail due to stress corrosion cracking if the vehicle has been used in extreme salt environments.

- Replace fasteners 1...10.

Replace the fasteners one after the other. Do not loosen and replace more than one

fastener at a time.

The fasteners are single use only. If there is a requirement for a fastener (either 4F0.698.998.A or 4F0698.998.D) to be rectified, then a new bolt must be used.

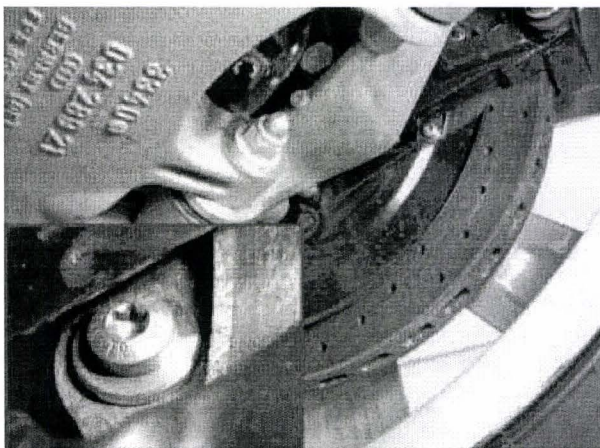
Any applicable Bentley models in the Continental family found to have CSiC brake discs secured with “Original” bolts must have this campaign applied

The rear disc retaining bolt can be viewed from inside the wheel. The front is checked through the wheel spokes
