Service Bulletin

Subject: MIL ILLUMINATION WITH DTCs P219A:00 AND/OR P219B:00	Bulletin No: 01-027/13
	Last Issued: 10/31/2013

2011-2013 CX-9

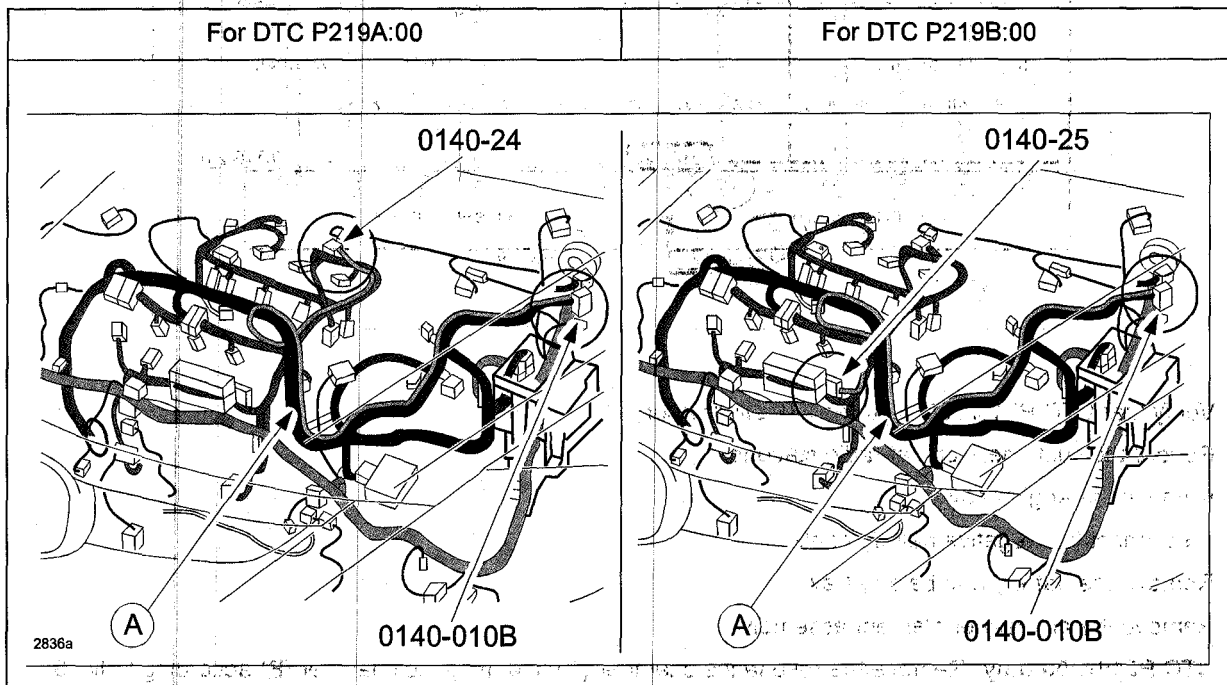
The DTCs may be caused by abnormal electrical noise within the engine harness of certain vehicles. To eliminate this concern, separate the A/F sensor signal lines from the emission harness by installing the short cord service part detailed in this bulletin.

- The repairs are slightly different depending on which DTC is stored in PCM memory. Be sure to proceed to the correct repair for the DTC that is found.
 - If both DTCs are stored in PCM memory, complete both repairs in this bulletin.
2. Remove (pull out) four (4) terminals from PCM-connector 0140-010B.
 3. Replace the four (4) removed terminals with the correct four (4) short cord terminals.
 4. Route the short cord (A) from connector 0140-010B and the A/F sensor connector 0140-24 (for DTC P219A:00) OR connector 0140-25 (for DTC P219B:00).

5. Pull out two (2) A/F Sensor terminals (C and E) from connector 0140-24 (for DTC P219A:00) OR connector 0140-25 (for DTC P219B:00), then install them into the short cord connector.
