Service Bulletin

Subject: MIL ILLUMINATION WITH DTCs P219A:00 AND/OR P219B:00	Bulletin No: 01-027/13
	Last Issued: 11/12/2013

2011-2013 CX-9

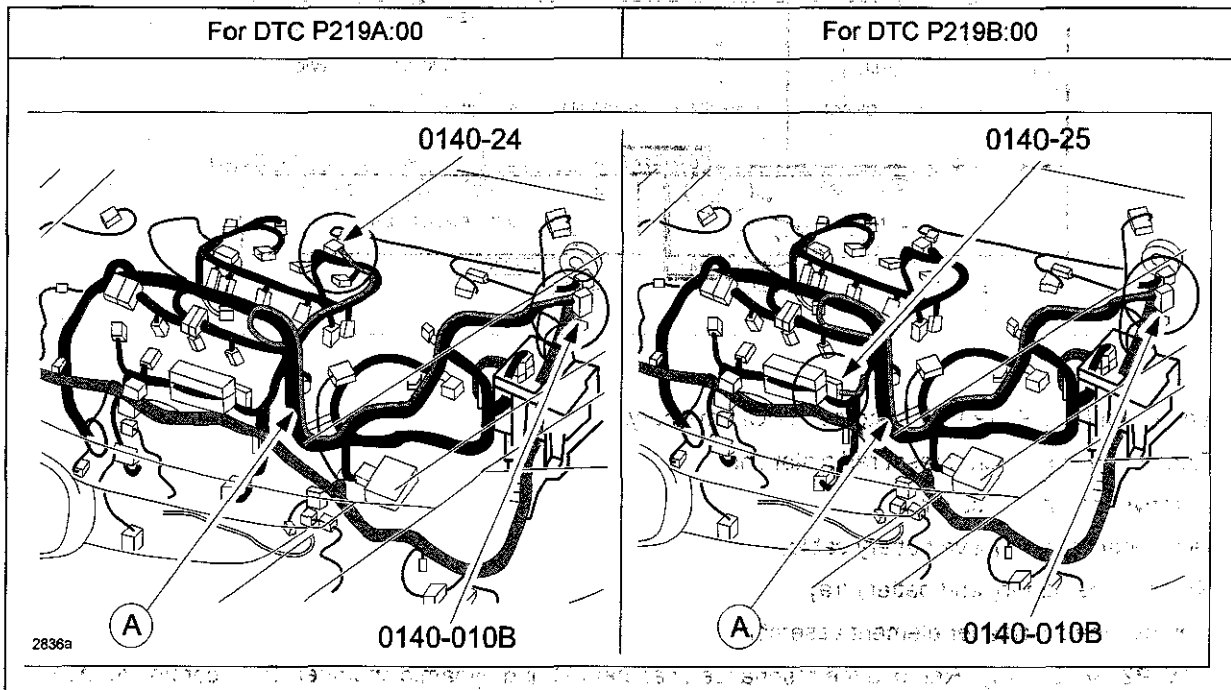
- The repairs are slightly different depending on which DTC is stored in PCM memory. Be sure to proceed to the correct repair for the DTC that is found.
 - If both DTCs are stored in PCM memory, complete both repairs in this bulletin.
2. Remove (pull out) four (4) terminals from PCM connector 0140-010B.
 3. Replace the four (4) removed terminals with the correct four (4) short cord terminals.
 4. Route the short cord (A) from connector 0140-010B and the A/F sensor connector 0140-24 (for DTC P219A:00) OR connector 0140-25 (for DTC P219B:00).

5. Pull out two (2) A/F Sensor terminals (C and E) from connector 0140-24 (for DTC P219A:00) OR connector 0140-25 (for DTC P219B:00), then install them into the short cord connector.
