GROUP	NUMBER			
CO HYUNDAI NEW THINKING. NEW POSSIBILITIES	Campaign	13-01-038			
Technical Service Bulletin	DATE	MODEL(S)			
rechnical Service Bulletin	September 2013	2013 MY Santa Fe (NC)			
SUBJECT: OVERHEAD CONSOLE LA	ECT: OVERHEAD CONSOLE LAMP INSPECTION AND REPLACEMENT				
(SERVICE CAMPAIGN TQ4)

This bulletin describes the procedure to inspect and/or replace the Santa Fe overhead console lamp.

### Applicable Vehicles: 2013 Model Year Santa Fe (NC)

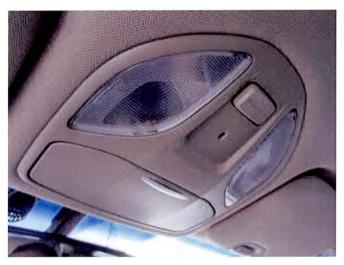
Verify ALL the operations of the Overhead Console:

- Lights
- Door Ajar Switch
- Sunglass Holder
- Sunroof (if equipped)
- Sunshade (if equipped)
- Power Tailgate (if equipped)

6. Install the replacement Overhead Console in reverse order of the removal.
