GROUP ACC	MODEL 2014MY Forte (YD)
	NUMBER 008	DATE October 2013
TECHNICAL SERVICE BULLETIN		
SUBJECT: SERVICE ACTION: GAP BETWEEN FORTE SPOILER AND TRUNK LID (SA154)

This issue number is SA154.

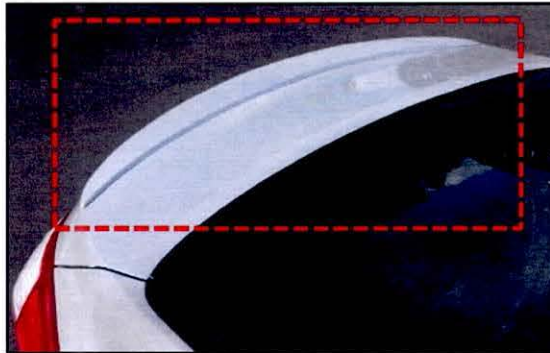
Some 2014MY Forte vehicles produced from April 24, 2013 to August 27, 2013 and equipped with a Kia accessory spoiler, may exhibit a gap forming between the adhesive tape on the spoiler and the trunk lid. To inspect for and to correct this condition, follow the procedure outlined in this TSB. If a gap has formed, remove the original spoiler and follow the instruction sheet enclosed with the new accessory part to install the replacement spoiler. Kia is requesting the completion of this Service Action on all affected vehicles, including dealer stock. Before conducting the procedure, verify the vehicle is included in the list of affected VINs.
