GROUP BOD	MODEL Sorento (XMa) 2011-2013MY
	NUMBER 093 (REV 3, 10/31/2014)	DATE February 2013

## TECHNICAL SERVICE BULLETIN

**SUBJECT:** SECOND ROW SEAT INOPERATIVE OR DIFFICULT TO RELEASE

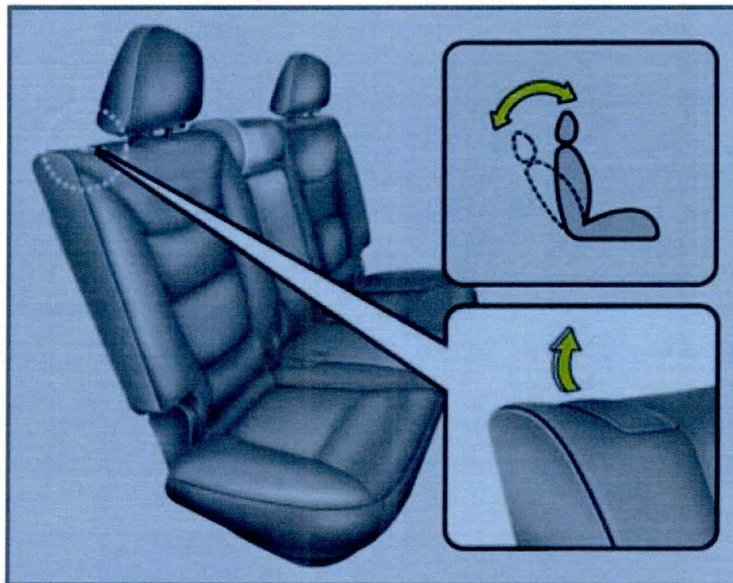
This bulletin provides information related to some 2011-2013MY Sorento (XMa) vehicles, produced from October 26, 2009 to November 5, 2012, which may exhibit a concern related to the second row seats being inoperative or difficult to release. It is important to note that some amount of effort is required to fold the 2nd row seats. To correct this condition, follow the service procedure outlined in this TSB.
