MODEL
Sorento (XMa)
2011-2013MY

NUMBER
093 (Rev 1, 08/22/2013)

TECHNICAL SERVICE BULLETIN

SUBJECT: SECOND ROW SEAT INOPERATIVE OR DIFFICULT TO RELEASE

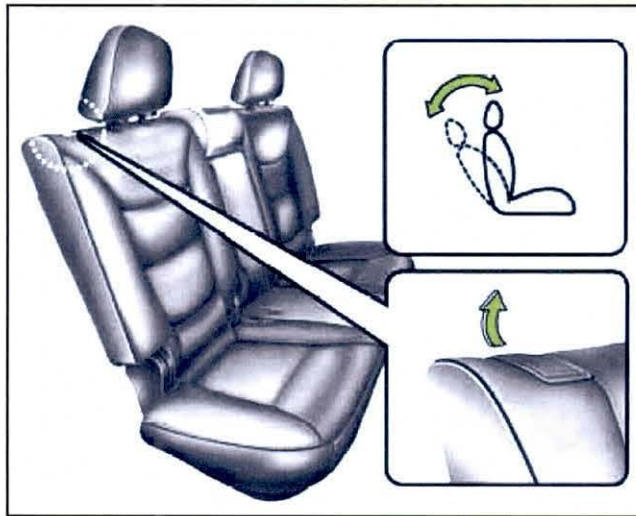
This bulletin provides information related to some 2011-2013MY Sorento (XMa) vehicles, produced from October 26, 2009 to November 5, 2012, which may exhibit a concern related to the second row seats being inoperative or difficult to release. It is important to note that some amount effort is required to fold the 2nd row seats. To correct this condition, follow the service procedures outlined in this TSB. Refer to the table below for detailed information on each concern and the associated service procedure.

Service Procedure	Concern
1	NO TENSION ON RECLINING HANDLE (RH SIDE (40%) SEAT / 5-PASSENGER MODEL)
2	NO TENSION ON RECLINING HANDLE (LH SIDE (60%) seat / 5 OR 7 PASSENGER MODEL)
3	EXCESS TENSION ON RECLINING HANDLE (BOTH SIDES)
