Subject: TAPPING NOISE WHERE EDGE OF DASHBOARD MEETS WINDSHIELD	Bulletin No: 09-004/13
	Last Issued: 03/06/2013

2013 CX-5 vehicles with VINs JM3KE*****122583 ~ 146712 (produced May 6, 2012 ~ Aug. 31, 2012)

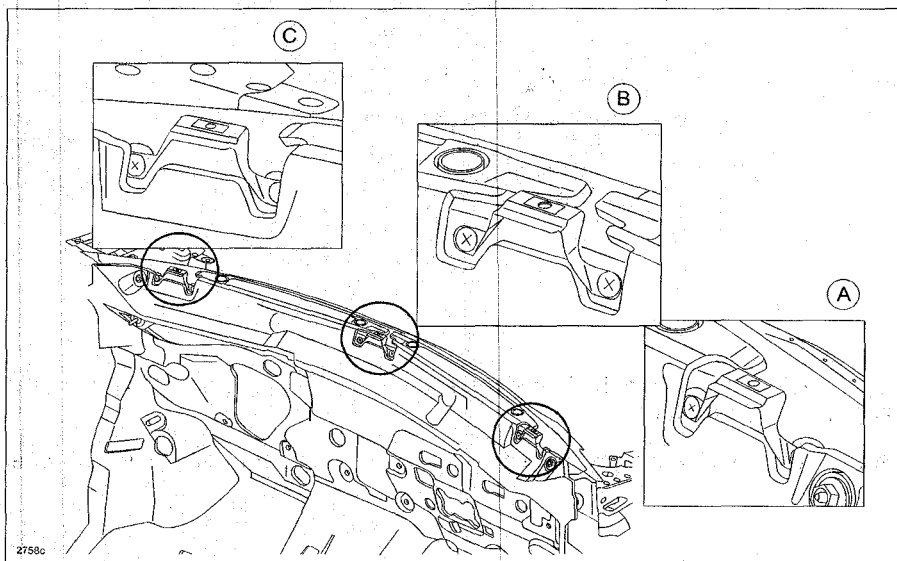
There are (3) three brackets (left, center and right) on the body-side as shown below (A). A felt pad is attached to each bracket for noise prevention. However, depending on the VIN and production date of the vehicle, felt pads may or may not have been attached to all three brackets. Vehicles without felt pads may experience a tapping noise when driving over bumps or rough roads.

Production date ranges for vehicles with and without felt pads: O = with felt pads, X = without felt pads.
