Subject: TOMTOM NAVIGATION SYSTEM SERVICE INFORMATION	Bulletin No: 09-015/13
	Last Issued: 05/07/2013

M-TIPS

UNIQUE REPAIR INFORMATION FOR
MAZDA TECHNICIANS

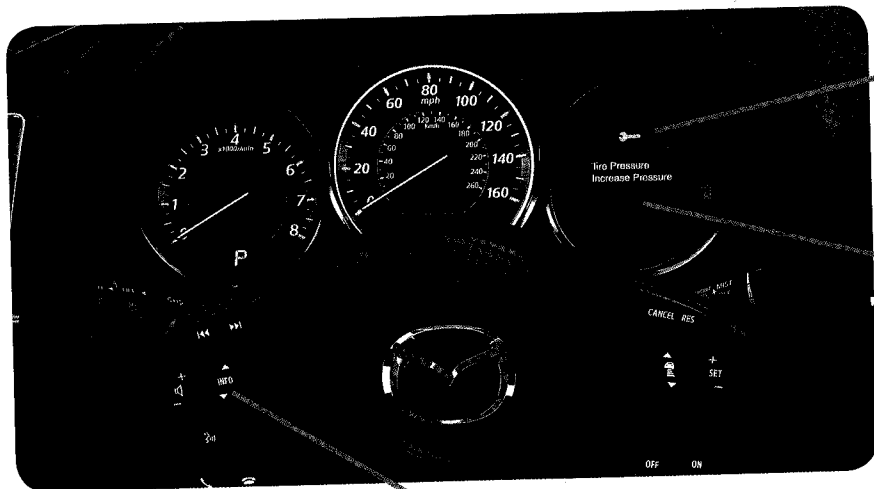
Multi-Information Display

Some customers may complain about a TPMS malfunction when they see the "Tire Pressure Increase Pressure" message displayed in the Instrument Cluster Multi-Information Display. This message is a preset service reminder to check the tire air pressures. **It is not a low tire pressure warning or a TPMS malfunction.**

The Maintenance Monitor may have been turned ON during PDI without the customer's knowledge; consequently, when the preset time period elapsed, the customer could misinterpret the message as a TPMS malfunction.

1. Use the steering wheel INFO switch to navigate to the "Maintenance" section of the Multi-Information Display.
2. Select "Tire Pressure"
3. Select "Set Time"
4. Set new values (if current values are being reused, skip to the next step)
5. Press the INFO button

1. Use the steering wheel INFO switch to navigate to the "Maintenance" section of the Multi-Information Display.
2. Select "Tire Pressure"
3. Select OFF

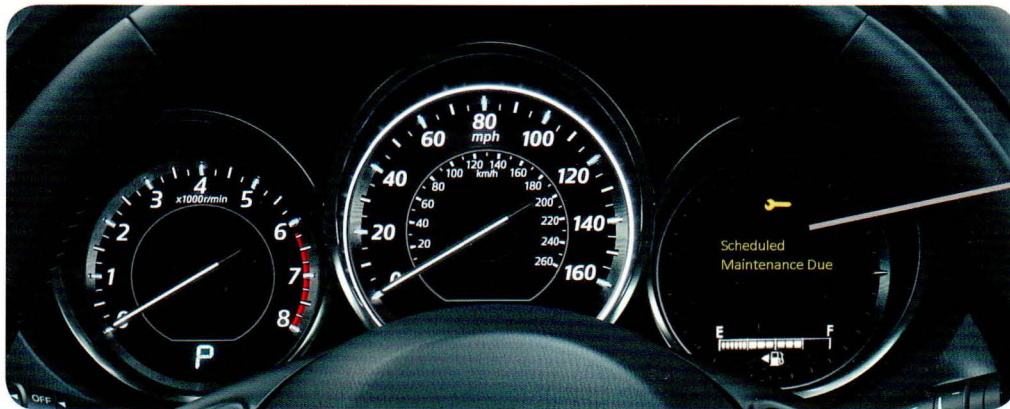
Multi-Information Display

When performing non-maintenance related repairs on a vehicle equipped with a Multi-Information Display, it is a good practice to check the Maintenance Monitor remaining time and distance. If the remaining time and/or distance shows that service will be required soon, inform the customer of the needed service during the current dealer visit. This practice will prevent an unnecessary customer return trip to your dealer.

The Maintenance Monitor factory default setting is OFF. If the customer turned it ON, check the remaining time and distance.

1. Use the steering wheel INFO switch to navigate to the "Maintenance" section of the Multi-Information Display.
2. Select "Scheduled"
3. Move highlight to "Set Time" and make a note of the remaining days
4. Move highlight to "Set Distance" and make a note of the remaining miles
5. Select "Back"
6. Select "Tire Rotation"
7. Move highlight to "Set Distance" and make a note of the remaining miles
8. Select "Back"
9. Select "Tire Pressure"
10. Move highlight to "Set Time" and make a note of the remaining days

Note: If the customer approves a Maintenance Monitor service, be sure to reset the reminders after the service is performed.

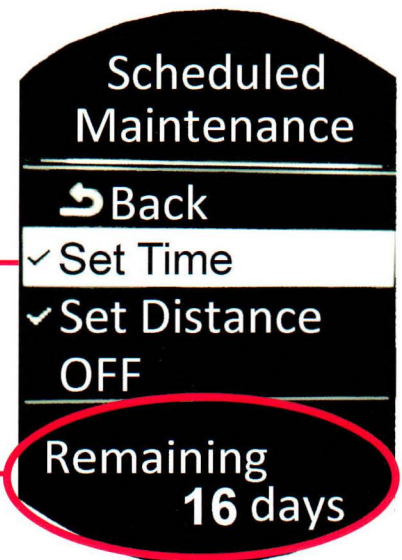
Example:

The "Remaining 16 days" above will not display a "Scheduled Maintenance Due" message; however, at "Remaining 14 days", the "Scheduled Maintenance Due" message will be displayed.

The customer may be upset when the "Scheduled Maintenance Due" message is displayed 2 days after repair. The customer will have to make an unnecessary return trip to your dealer.

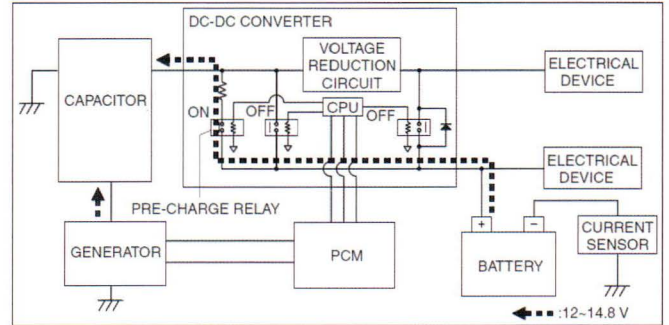
In Pre-charge mode

- There is excessive dark current.
- The capacitor's voltage decreases because the vehicle is stored for a long period without running the engine.

The Multi-Information Display will display an i-ELOOP warning message after engine startup.

When the warning message is displayed, allow the engine to idle until the warning message is no longer displayed. This time is needed for normal generator operation. The vehicle may be driven when the message is no longer displayed.
