Subject: EXCESSIVE OPERATING NOISE WHEN SLIDING POWER SEAT	Bulletin No: 09-021/13
	Last Issued: 07/19/2013

2014 Mazda6 equipped with power seats with VINs lower than JM1GJ*****125980 (produced June 1, 2013)

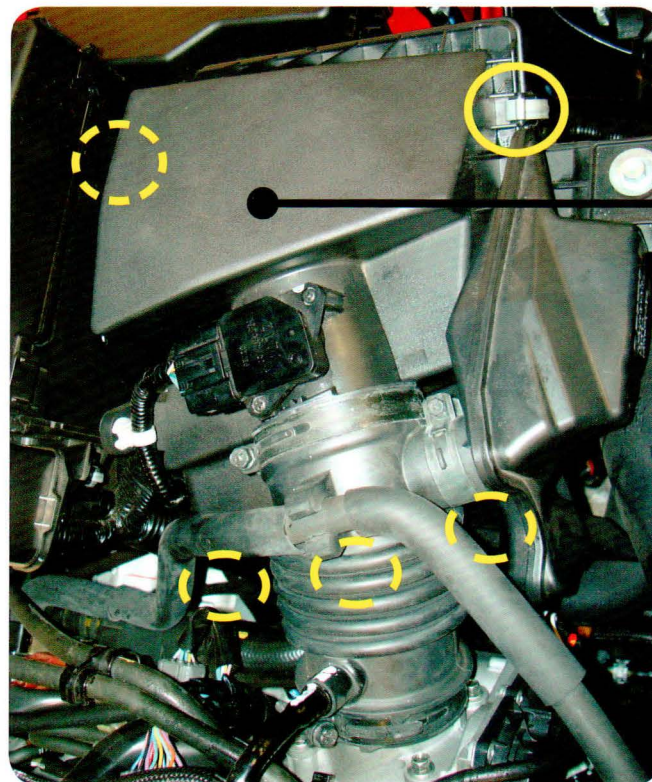
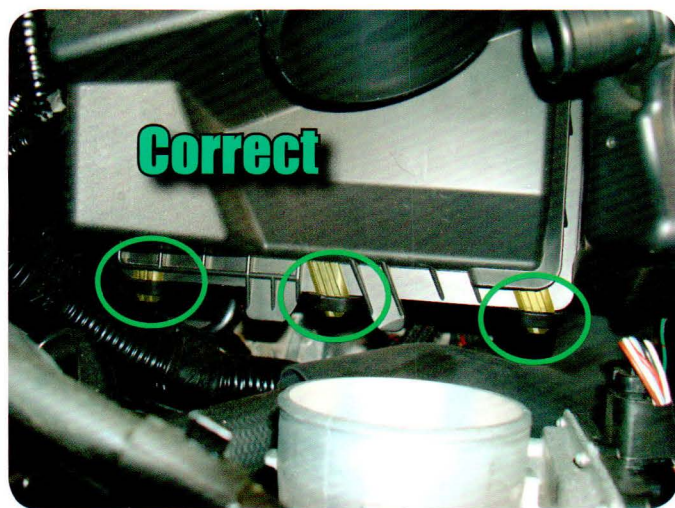
Air cleaner cover

When replacing or inspecting the air cleaner element, make sure the air cleaner cover is properly secured to the lower air box. Some air cleaner covers have 3 inserts on one side and 2 anchors on the other side. A MIL may be stored and/or a rough idle may occur if the air cleaner cover is not installed correctly.

Correct

Left side of the air cleaner cover is inserted into the lower air cleaner housing correctly.

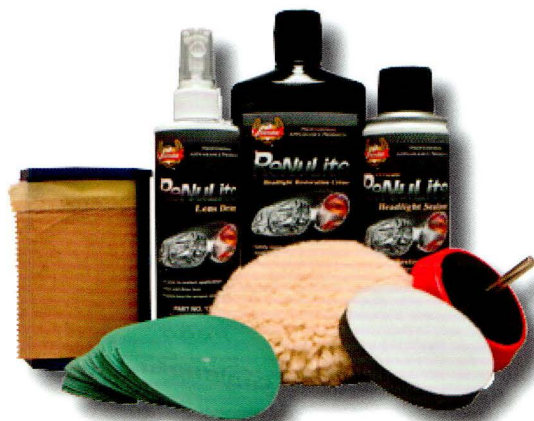
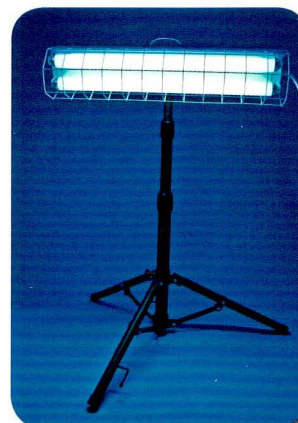
Presta ReNuLite® Headlight Restoration Kit

The headlight lens discoloration or cloudiness is a problem plaguing the automotive industry. Varying degrees of this condition can be found on vehicles 4 years or older, regardless of vehicle make or model. The problem is caused by ultraviolet (UV). This degradation of the original hardcoat on the lens. This exposes the unprotected polycarbonate surface, which quickly yellows and turns cloudy.

To correct this concern and provide a long term solution, Mazda has approved the Presta ReNuLite® Headlight Restoration Kit. This Kit has three distinct advantages over similar repair products found on the market today.

The Presta kit will repair up to 10 vehicles. Also shown is the optional UV curing light. This light will be required only if adequate sunlight is not available to cure the applied sealant.

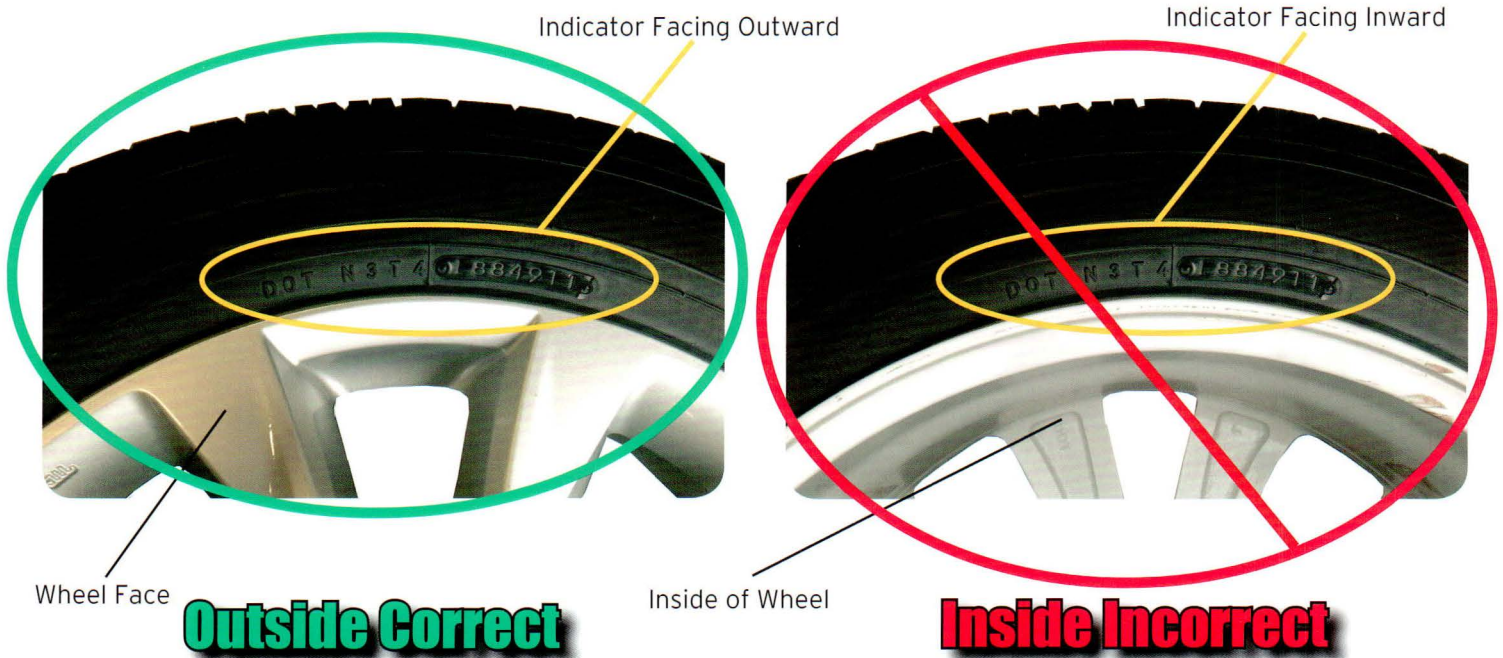
When installing a replacement tire on a customer's vehicle, make note that the tire sidewall indicators below face outward.

Note: DOT XXXX facing inward is normal

Incorrect tire installation may cause the vehicle to drift or pull while driving.

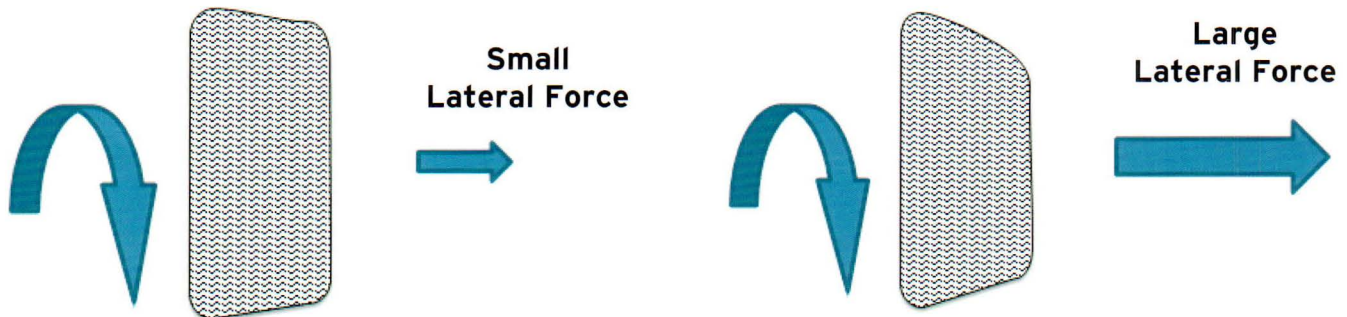
Conicity

During the tire manufacturing process, there is some amount of conicity (lateral force). Tire conicity results when the tire belts are not perfectly aligned when the tire is built. Tire conicity should not be confused with a separated, worn, or damaged tire.

When a cone rolls, it rolls in a circle towards the point of the cone. This phenomena is known as conicity. The amount of lateral force varies from tire to tire.

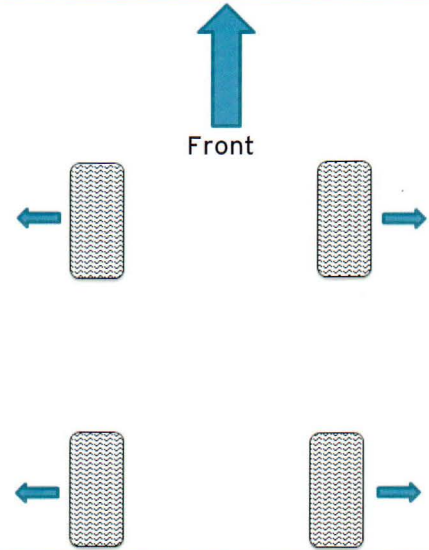
Correct Tire Installation

All tires are installed correctly with the indicators facing outward. Lateral forces offset each other. When the vehicle is driven, it drives straight.
