<b>Subject:</b>  HOOD VIBRATION WHILE DRIVING AT HIGHWAY SPEED	<b>Bulletin No:</b> 09-036/13
	<b>Last Issued:</b> 12/10/2013

2013-2014 CX-5 vehicles with VINs lower than JM3KE\*\*\*\*\*387092 (produced before September 1, 2013)

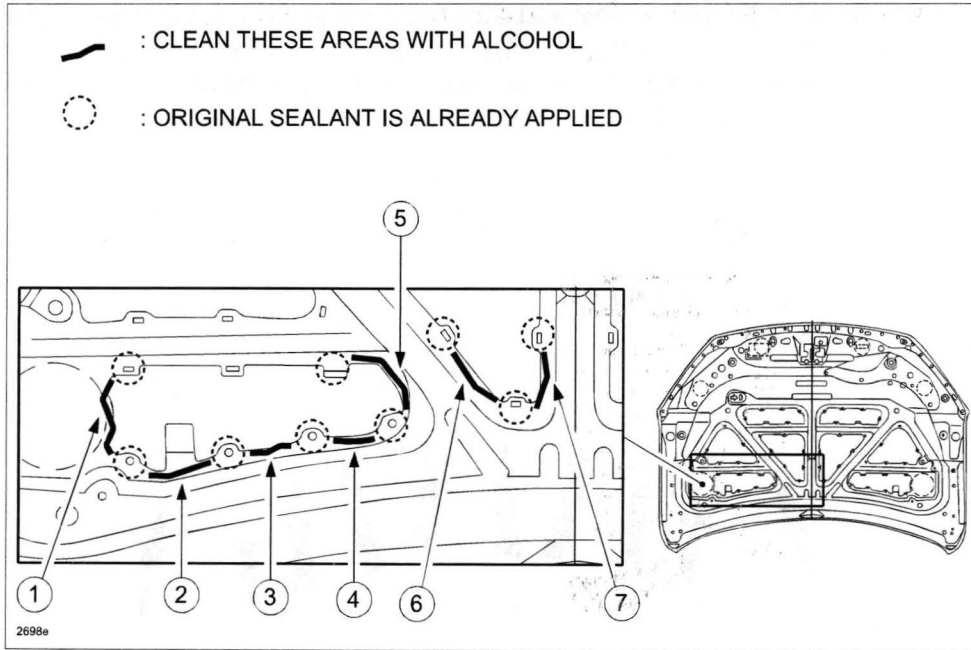
**NOTE:** There are seven (7) areas on the left side of the hood and seven (7) areas on the right side of the hood to be cleaned (left side shown below).
