# Ticking Noise from Rear Package Tray

Service Category Vehicle Exterior

Section Body Structure

YEAR(S)	MODEL(S)	ADDITIONAL INFORMATION
2013	FR-S	WMI(s): JF1

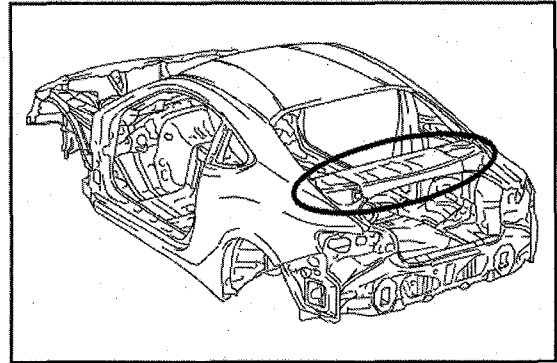
Figure 1.

1. Test drive the vehicle to confirm that a noise is coming from the rear package tray area circled in Figures 2 and 3.
