Service Bulletin

Bulletin No.: PIP5029D

Subject: Engine Misfires due to Major Carbon Deposits on the Intake and or Exhaust Valves

Models: 2009-2014 Buick Enclave
2009-2014 Buick Lacrosse
2008-2014 Cadillac CTS, STS
2010-2014 Cadillac SRX
2013-2014 Cadillac ATS, XTS
2008-2010 Chevrolet Cobalt SS, HHR SS
2009-2014 Chevrolet Traverse
2010-2014 Chevrolet Camaro, Equinox
2011-2014 Chevrolet Captiva
2012-2013 Chevrolet Impala
2014 Chevrolet Impala, Impala Limited
2009-2014 GMC Acadia
2010-2014 GMC Terrain
2007-2010 Pontiac Solstice GXP
2009-2010 Saturn Outlook
2007-2010 Saturn Sky Redline

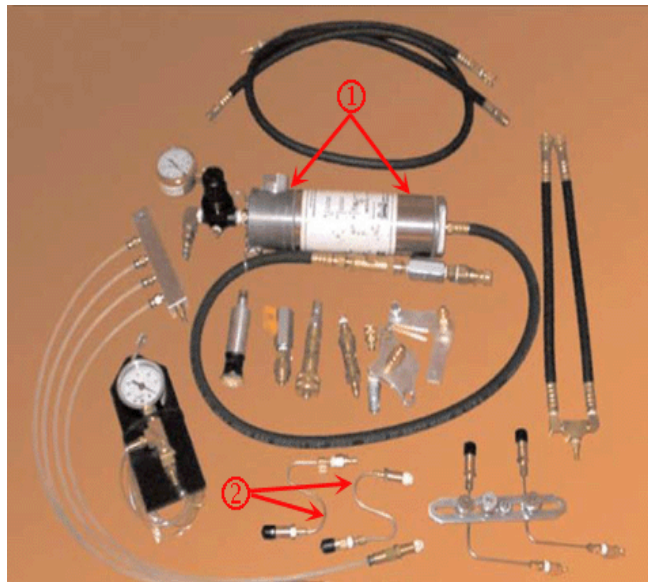
Kent Moore Tool Kit # J-45076

1. Pressurized Canister from J-45076 is shown - J-35800-A is similar (Equivalent Pressurized Canister Acceptable)
2. Throttle Body Cleaning Adapters J-45076-46 and J-45076-55 shown (Equivalent Adapters Acceptable)

Notice: J-45076 was originally released to Cadillac dealers for decarboning Northstar engines but it has since been discontinued. This kit came with the pressurized canister and throttle body cleaning adapters shown above. As mentioned above, the J-35800-A is another pressurized canister that can be used. It was originally released in the 1990s for cleaning fuel injectors on the 4.3L, 5.0L, and 5.7L truck engines. If these tools are not available, it is also acceptable to use equivalent tools to perform this decarboning procedure.
