Service Bulletin

Bulletin No.: PIP5038B

Subject: SES Light, Engine Misfire, and/or Shudder - Inspect Ignition Coils

Models: 2009 Buick Enclave
2008-2009 Cadillac CTS, STS
2009 Chevrolet Traverse
2009 GMC Acadia
2009 Saturn Outlook
With Direct Injected 3.6L V6 Engine (RPO LLT)

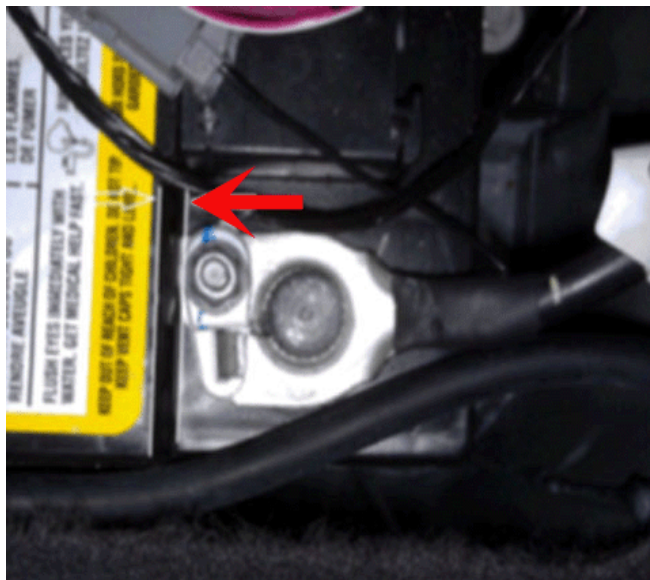
3419866

On the Enclave, Acadia, Traverse and Outlook products, proper alignment of the battery clamp to the battery is essential in ensuring that the battery clamp fully seats on the battery post. Improper alignment will result in the battery clamp interfering with the case of the battery.

This interference will give a false indication of a tight battery connection.

This is most likely to occur on the negative battery terminal due to the short length of the battery cable.

CTS and STS: Negative battery cable at battery and cable to body bolt. – Clean both sides of the terminal and mounting surface. Must be free of corrosion at mounting, terminal, attachment bolt surfaces.
