**NUMBER:** 25-003-13

**GROUP:** Emissions Control

**DATE:** February 28, 2013

Malfunction Indicator Lamp Illumination Due To Oxygen Sensor

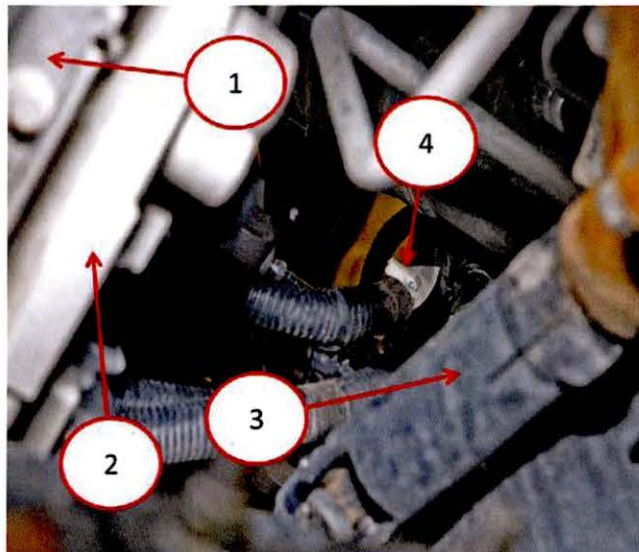
**Fig. 1 LOCATION OF TRANSMISSION HARNESS TAG, VIEWED FROM BELOW**

- 1 - Engine Oil Pan
  - 2 - PCM
  - 3 - Steering Shaft
  - 4 - Transmission Wiring Harness Tag Location
-

1. Determine if the Oxygen Sensor Module terminals require replacement. Inspect the tag on the Transmission Wiring Harness for the part number suffix (the last two digits). This wiring harness tag is attached to the harness at a point usually most visible from under the hood. Initially, it is easiest to locate the tag from under the vehicle. Follow the harness from the PCM (front) connector up to the takeout that heads toward the driver's side of the vehicle. The tag is located on this takeout, near the frame rail, behind the left front wheel well splash shield. See (Fig. 1) and (Fig. 2) for tag location references.

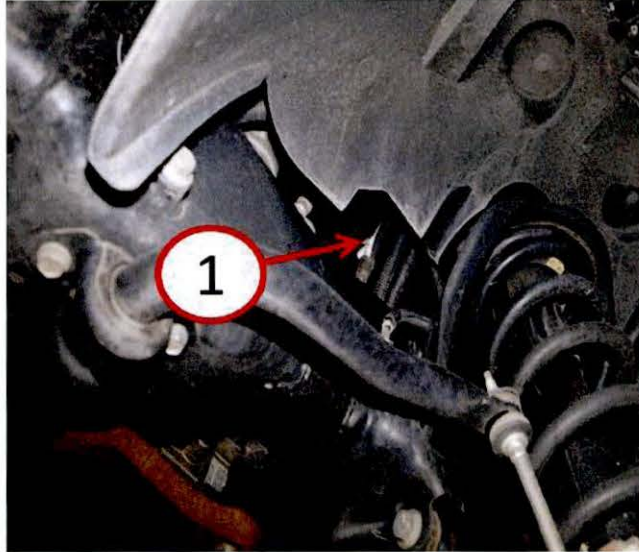
**Fig. 2 TRANSMISSION HARNESS TAG, VIEWED FROM LEFT WHEEL WELL**

1 - Transmission Tag as Visible Through Drivers Side Wheel Well

2. The harness part number is located on the left side of the tag between the 2 bar codes. Does the part number end with the suffix AC ?
  - a. Yes >>> If the suffix is AC, The Repair Procedure for Module Connector **IS** required. Perform the repair procedure below.
  - b. No >>> This bulletin does not apply. Ensure SB's 25-004-12 and 18-012-12 REV. A (or later bulletins) have been completed.

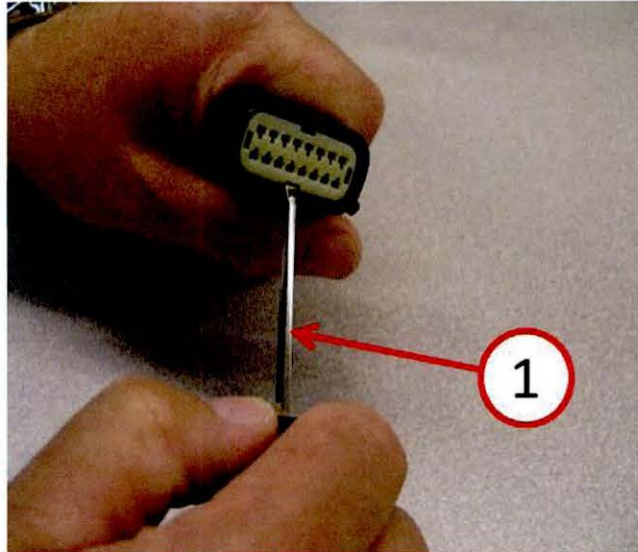
**Fig. 3 PRY OUT THE TPA 5MM**

1 - Small Blade (3mm Wide Max) Screwdriver

1. Open hood.
2. Disconnect and isolate both negative battery cables.
3. Raise and support vehicle on a suitable hoist.
4. Disconnect the **Oxygen Sensor Module Connector** and remove the protective tape and plastic shield on the connector.
5. Using a narrow blade, flat screwdriver (3 mm wide max), pry the white TPA (white cover seen when looking in connector). Note travel of white TPA is only 5 mm until "click" is heard. This is the release point of the TPA. NOTE: the TPA is a device that locks the release finger so that when seated, terminal will not and cannot be disengaged, (Fig. 3) and (Fig. 4).

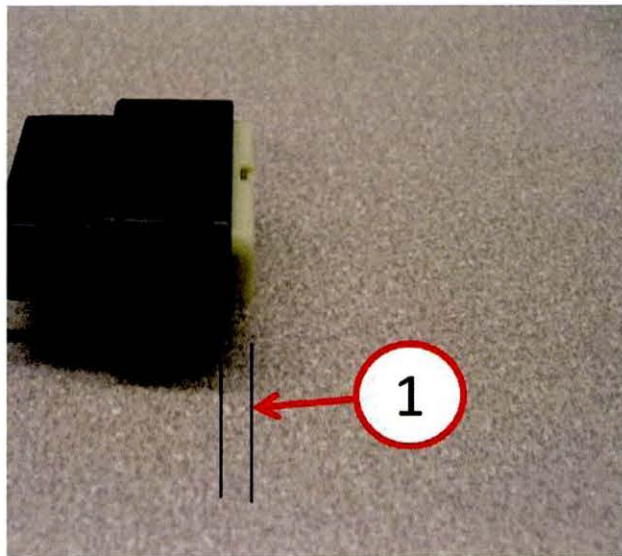
**Fig. 4 TPA EXTENDED 5MM**

1 - Extend TPA 5MM Only

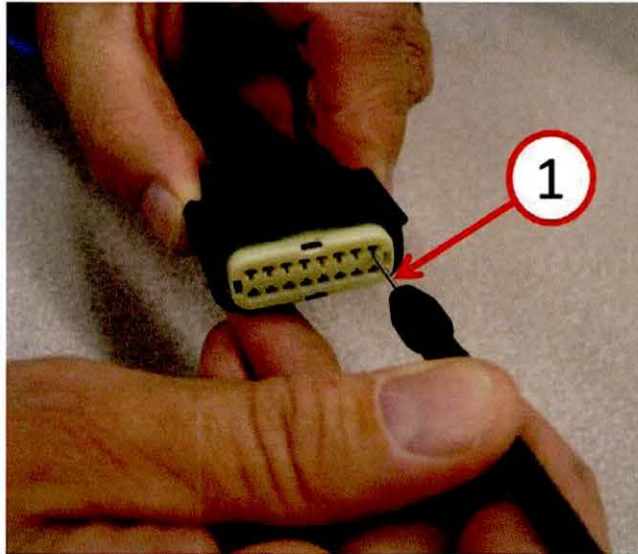
**Fig. 5 TERMINAL RELEASE TOOL INSERTED**

1 - Tool Inserted to Release Terminal From Connector

6. Insert either J-38125-217 (Kent Moore number) OR MX 150-MX150L / 63813-1500 (Molex) OR a fabricated tool, (consisting of a chamfered 1mm drill bit installed with the cutting end of the drill in the handle of Miller Tool #8351), into TPA (module side of connector) into the desired "service port" until resistance is felt. (Fig. 5)
