Technical Service Bulletin

94 Daytime Running Light (DRL) inoperative

94 13 05 2032184/1 February 8, 2013.

Model(s)	Year	VIN Range	Vehicle-Specific Equipment
Q5	2013	All	Audi Xenon Plus with LED Daytime Running Lights
	2014

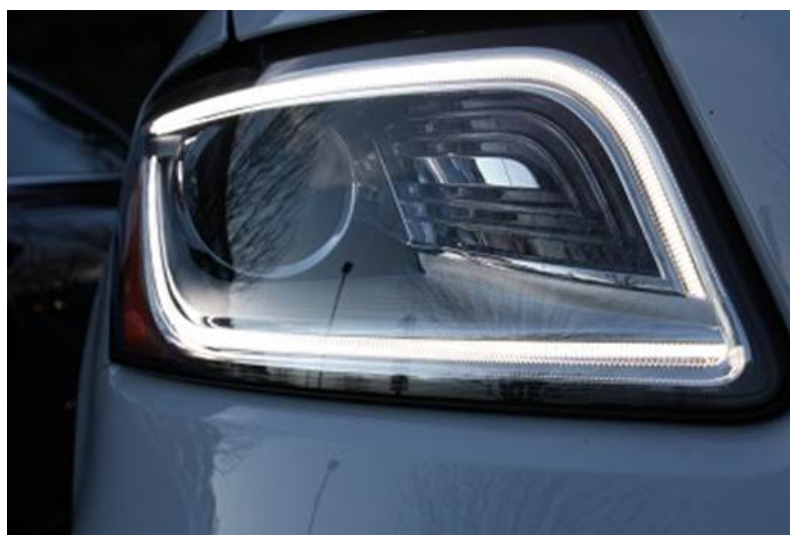
The MY2013+ Audi Q5 LED DRLs use light-emitting “pipes” instead of multiple individual LEDs. There are two light pipes per headlight. Each light pipe uses a single LED for illumination (Figure 1).

Figure 1. Upper and Lower light pipe illuminated.

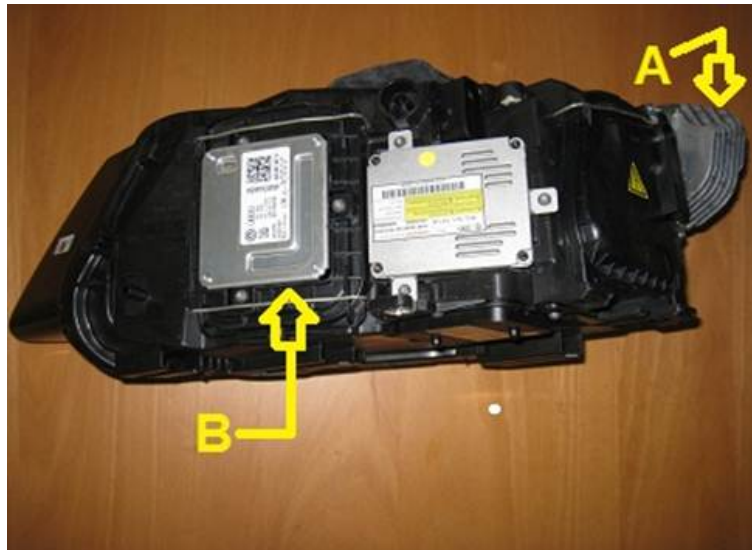
The LED unit with heat sink utilizes a gasket and is keyed into the headlight housing to maintain proper alignment of the LED to each light pipe. The LED units (L176 and L177, left and right, respectively) are controlled via a control module (J860 and J861, left and right, respectively) located separately on the backside of the headlight (Figure 2). These LED units and LED control modules are electrically interchangeable from side to side, but the LED units are mechanically specific to each headlight side.

Figure 2. Backside of headlight with LED heat sink (A) and LED control module (B).

1. With ignition off, remove DRL control module and check red connector at module. Secure it, if loose. If necessary, remove red connector and reinstall to be sure connector is engaged properly. The wire guide of the red terminal housing may impede connector engagement.
2. Turn ignition on to see if DRL is now operating to specifications. If it is not, proceed to step 3.
3. Remove headlight(s) according to repair manual. See *Repair Manual >> Electrical System >> Electrical Equipment >> 94 Exterior Lights, Switches >> Removal and Installation*.
4. With ignition off, remove LED DRL unit with heat sink from headlight housing (Figure 6).
5. With ignition off, inspect and secure all electrical connectors, if loose. Remove and secure the white connectors, even if they do not appear to be loose.
