## SERVICE BULLETIN

**APPLICABILITY:** 2013 MY BRZ

**NUMBER:** 12-145-13

**SUBJECT:** Condensation in Rear Combination Lamps,  
 Retaining Nut Change

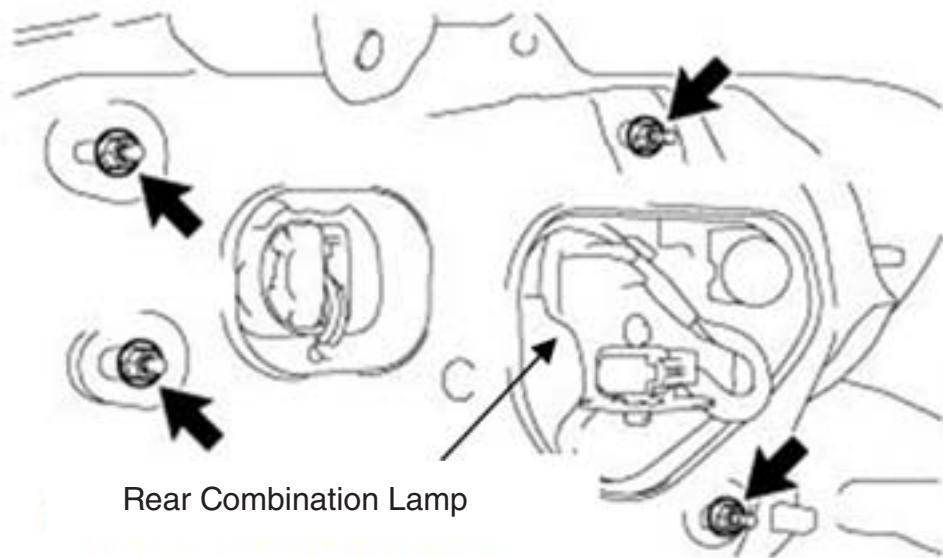
### Retaining Nut Locations (4)

Due to a smaller diameter flange surface, the original retaining nuts may distort the rear body panel mounting and sealing surfaces for the combination lamps enough to allow moisture seepage past the seals into the combination lamps and possibly the trunk area.

Remove the trunk floor mat, rear floor finish plate, inner trunk trim and the affected rear combination lamp assembly(ies) following the instructions in the applicable Service Manual.

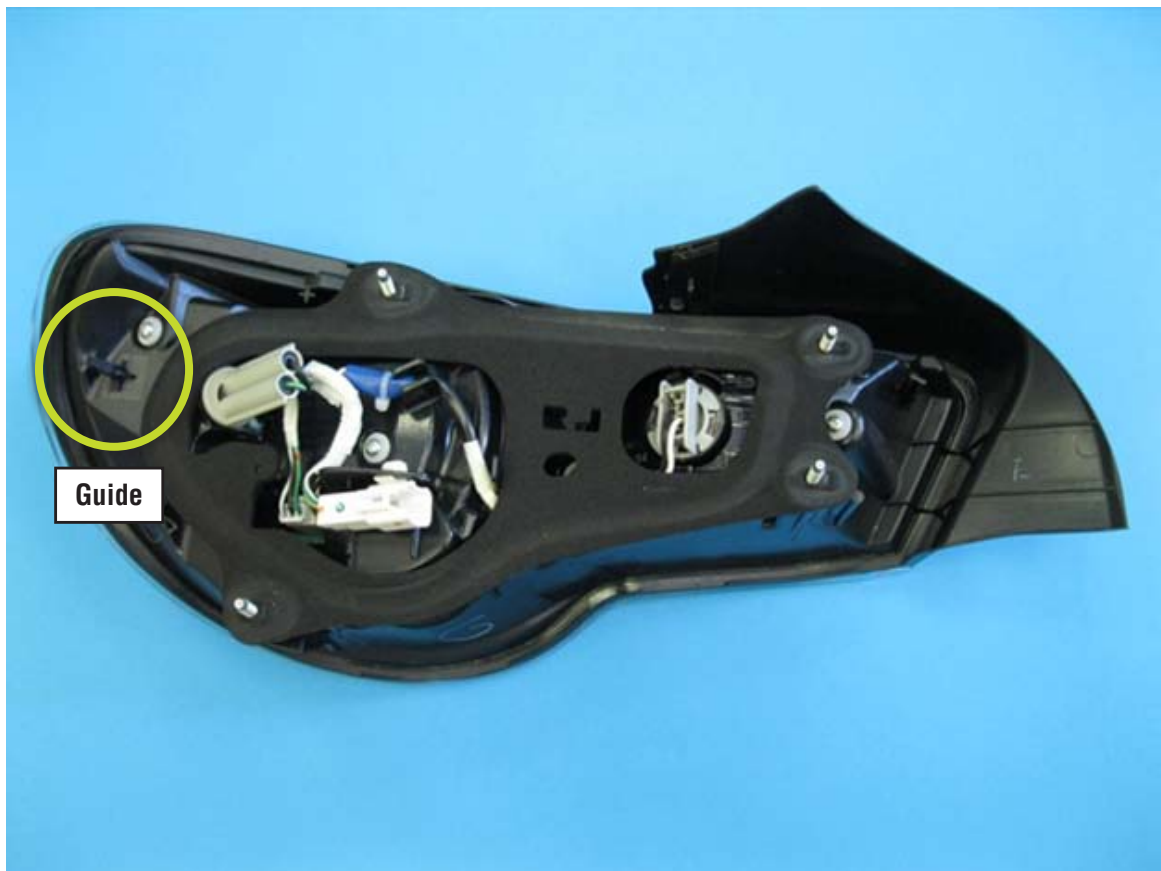
**NOTE:** There is a plastic guide on the outside corners of the combination lamps as shown in the photo below. Be careful when removing and reinstalling the lamps not to damage it.
