Technical Service Bulletin

PSS 96 Lane Change Assistant "Sensors Blocked" warning in DIS

96 13 60 2033943/1 May 23, 2013.

Model(s)	Year	VIN Range	Vehicle-Specific Equipment
A4/S4	2013	All	Lane Change Assistant
allroad	2013		
A5/S5/RS 5	2013

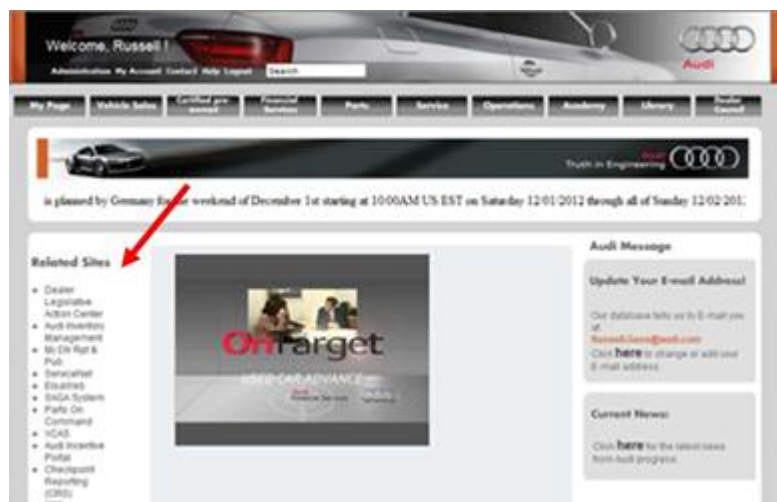
Figure 1. Related Sites section on Accessaudi.com landing page

1. Erase DTC(s).
2. Diagnose the vehicle according to the instructions listed below. If customer's vehicle condition matches the condition listed in the *Technical Background* of this PSS TSB, explain to the customer that a solution is forthcoming and that no repairs are necessary at this point.
3. Do not replace any components for this condition since this will not resolve the customer's concern.
4. Create a PSS record in the PSS application via the hyperlink in Accessaudi.com (Figure 1) or Technical Assistance page in Elsa (Figure 2).
