# Service Bulletin

Bulletin No.: 08-08-67-013H

**Subject:** Snap, Pop, Creak or Rattle Noise from Lift Off Roof Panel While Driving  
(Verify Condition and Perform Appropriate Repairs)

**Models:** 2005-2013 Chevrolet Corvette  
Equipped with Removable Clear Roof Panel RPO CC3, Removable Sun Roof Panel  
RPO CF7 or Dual Removable Roof Panels RPO C2L

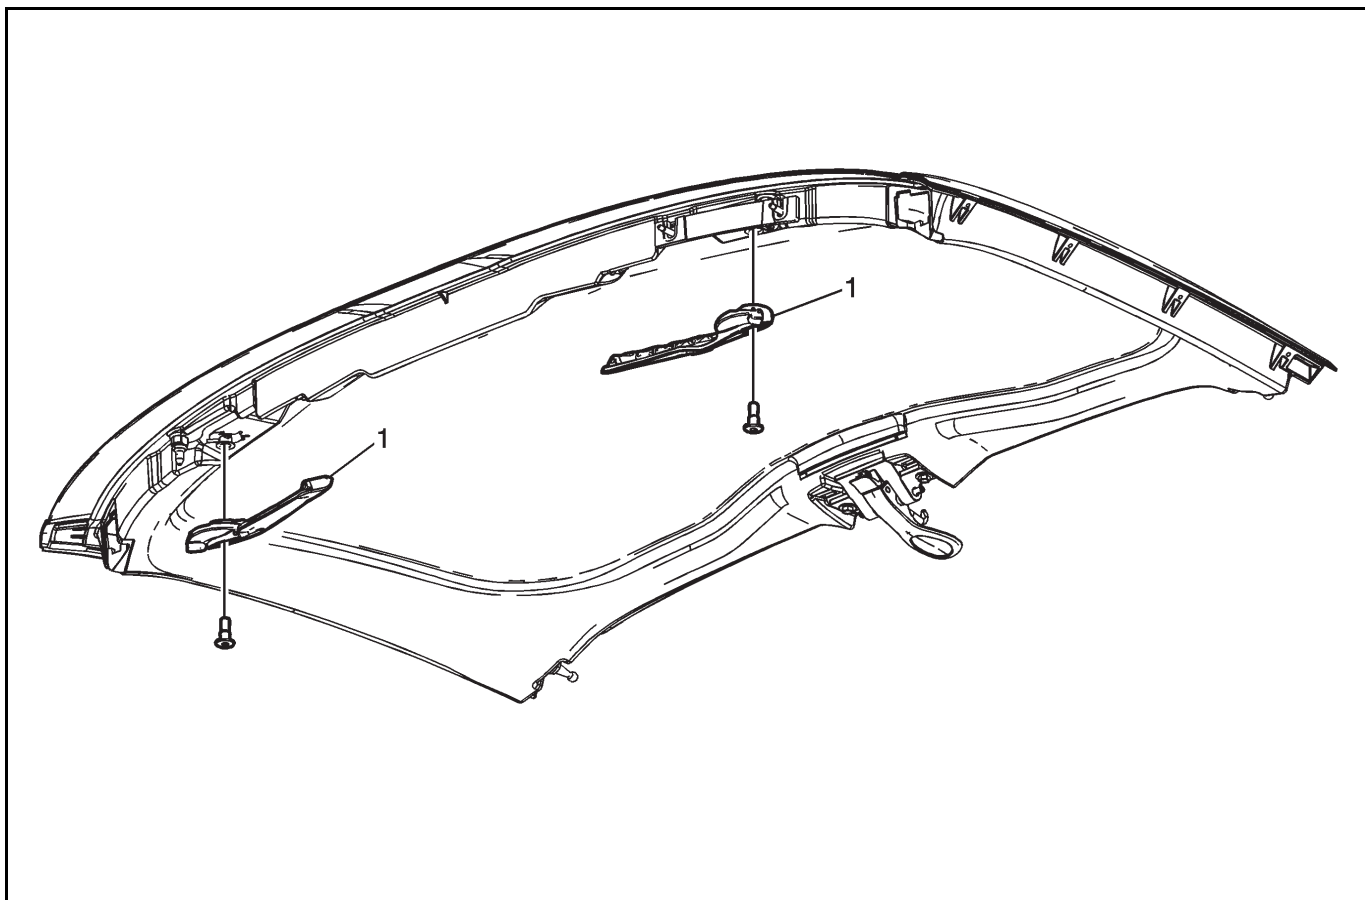
2128668

1. If the noise is verified to be coming from the front latch area, inspect the handle roller. identify the design, and the resulting repair, from the two choices below:

- If the roller is round and will spin on its axis (as shown above), they are early design handles and should be replaced. Replace the left and right front lift off roof panel handles with the current handle design parts noted previously, **and include the lubrication steps below.** Refer to Roof Lift Off Panel Front Latch Handle Replacement in SI.

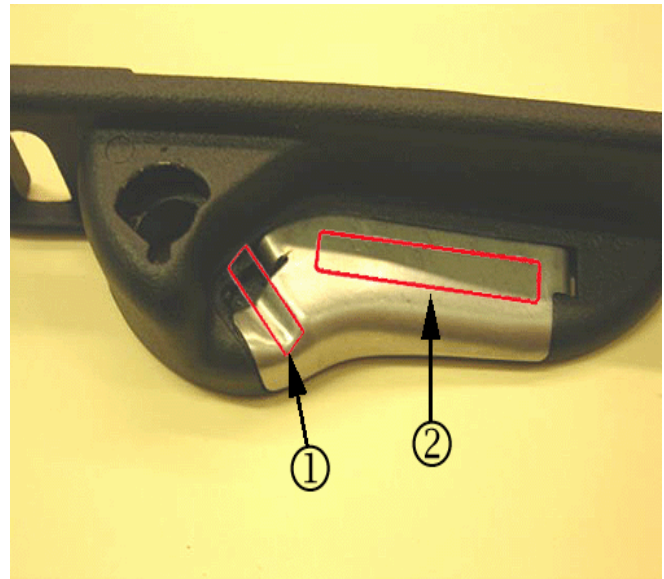
2236151

**Important:** Verify that the steel plate on the underside of the latch receiver is secured to the receiver. If any motion is detected when the plate is moved up or down, replace the receiver. **Because both of the receivers are adjustable up and down, make note of the location of the receiver plate prior to removing it.** Too much downward pressure may cause the roof to make noise, and too little can create a wind noise/water leak.

2. Whether the latch handles are replaced or the vehicle already has the current design, apply lubrication following the steps below:
  - 2.1. Add a small amount of dielectric silicone grease, GM P/N 12345579 (In Canada, P/N 10953481) to the barrel of the handle attaching bolt. DO NOT get grease on the bolt threads as it will reduce the effectiveness of the thread locking compound.

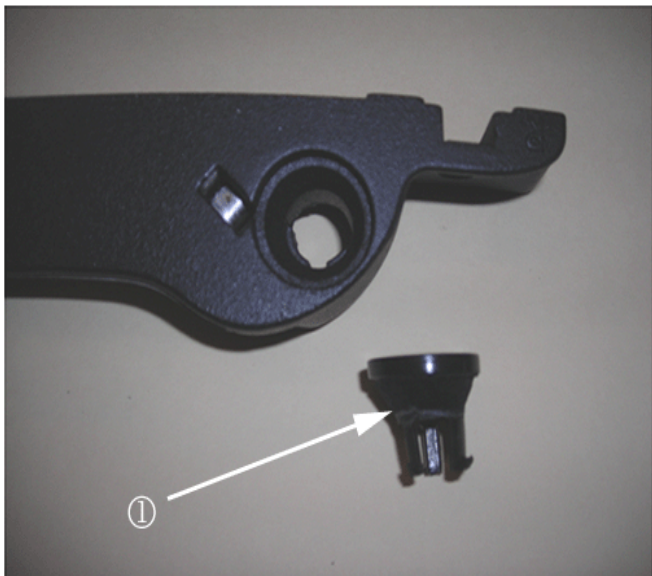
2236150

- 3.2. Once removed, inspect each insert (1) to verify the cones are not cracked or broken.

- 3.3. Also verify that the inserts have an 8 mm (0.31 in) wide wrap of flocking tape toward the top of the cone, as shown above. If the flocking tape is worn or is missing, repair following the latest version of Corporate Bulletin Number 05-08-59-003.
