# M-TIPS

UNIQUE REPAIR INFORMATION FOR  
MAZDA TECHNICIANS

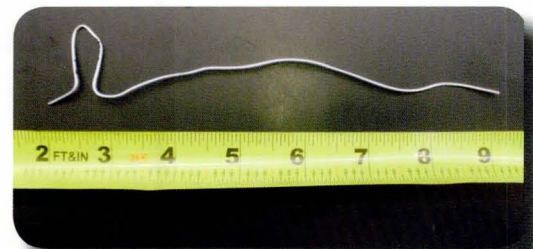
When draining motor oil, the oil flows in a steady stream after removing the drain plug. Just before the drain ends, the oil flow changes direction. On some vehicles, such as the 2012 Mazda3, this change may cause the motor oil to land on the engine undercover, creating an oily mess. Valuable time is wasted for engine undercover cleanup.

Engine undercover cleanup is necessary.

This oily mess can be avoided by using a mechanic's wire (approx. 9 inches) to guide the oil flow away from the engine undercover. Install the mechanic's wire just before draining ends.

Mechanic's wire installed.
