Recall Bulletin

PRODUCT SAFETY RECALL

SUBJECT: Power Window Master Switch Failure

MODELS: 2009 Pontiac Vibe

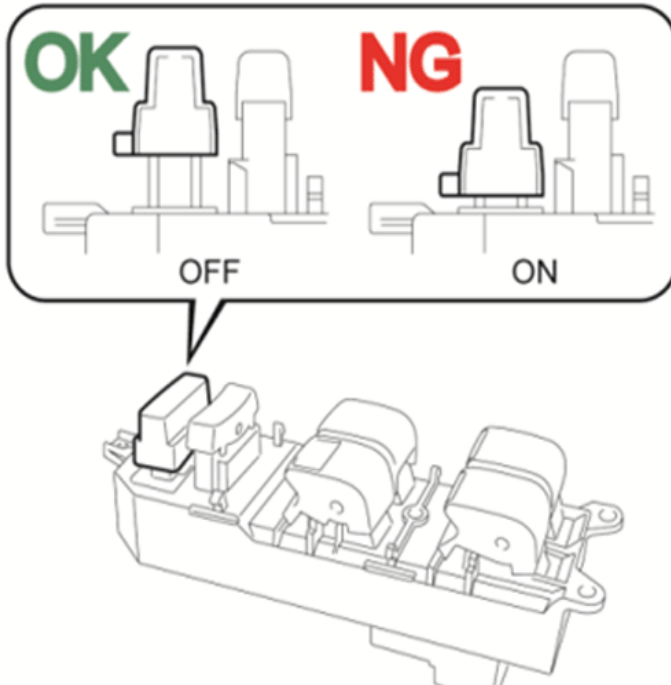
3021150

OK-Good
NG-No Good

- Removing the lock button while it is turned ON may damage the switch.
- To prevent damage, Do Not use tools.
