Program Bulletin

CUSTOMER SATISFACTION PROGRAM

SUBJECT: Front Strut - Noise

MODELS: 2012-2013 Chevrolet Colorado

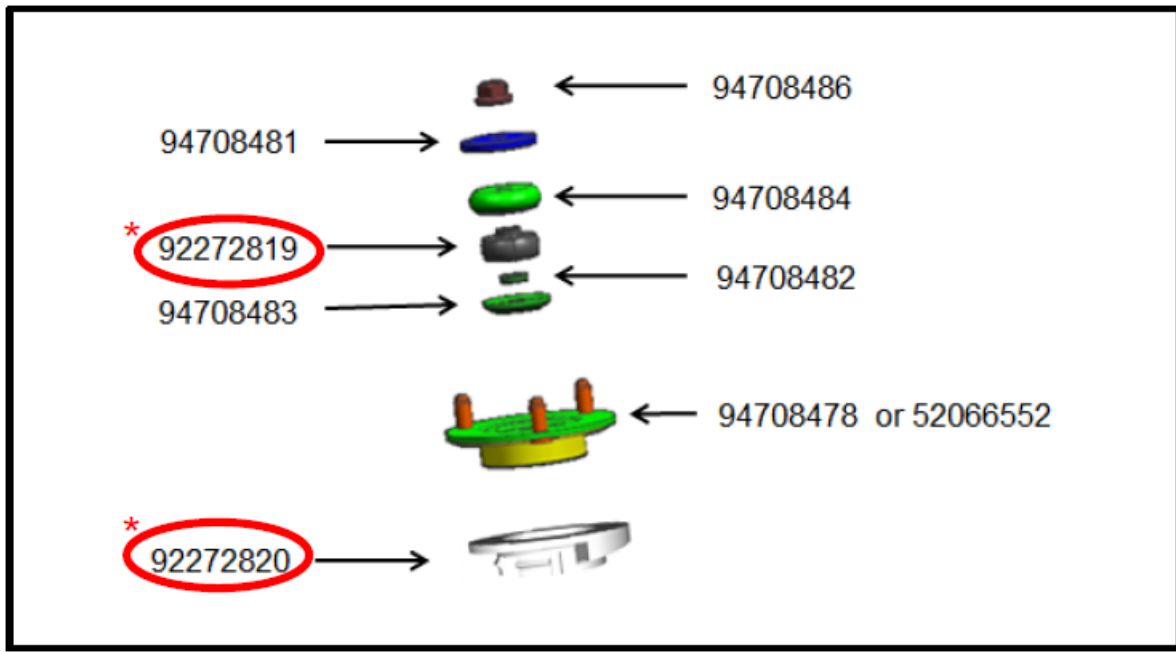
On some 2012-2013 model year Chevrolet Colorado vehicles, squeaking or creaking noise may be heard from the front suspension during driving.

Change the Spring Seat Isolator (Improved part – Part no 92272820) and BUMPER, FRT S/ABS UPR (LOWER) (Improved part – Part no 92272819) and other damaged part as necessary.

4. Remove the top mount plate. Ensure SI procedures are followed as the spring is under tension and injury could occur if incorrectly disassembled.
5. Refer to figure 1 - the lower bush (9) will be replaced as well as the spring seat isolator (not shown in figure 1). In addition, inspect the top mount bracket (4), cup washer (7), upper bush (8), and shocker absorber rod (1) for damage. Follow these guidelines to determine if these parts should be replaced:
 - Place a straight edge along the shocker absorber rod as shown in figure 4.
 - Measure the depth of wear on the shaft. If the wear is greater than 1mm, replace the shock absorber.
 - Inspect the steel washer (silver) that is pressed into the centre of the top mount bracket. If the washer has worn through to the black steel mount bracket, then replace the top mount bracket, refer figure 5.

- Inspect the upper bush (8), if the bush is out of shape or is damaged, replace the bush. In most cases it is expected that the upper bush can be reused. Do not replace it unless necessary.
- Inspect the cup washer (7) for distortion or other damage. Replace only if required.
