Service Bulletin

SUBJECT: Service Update for Inventory and Customer Vehicles
Software Enhancement Update
Expires with Base Warranty

MODELS: 2013 Chevrolet Sonic, Spark, Trax
Equipped with MyLink Radio (UF7)

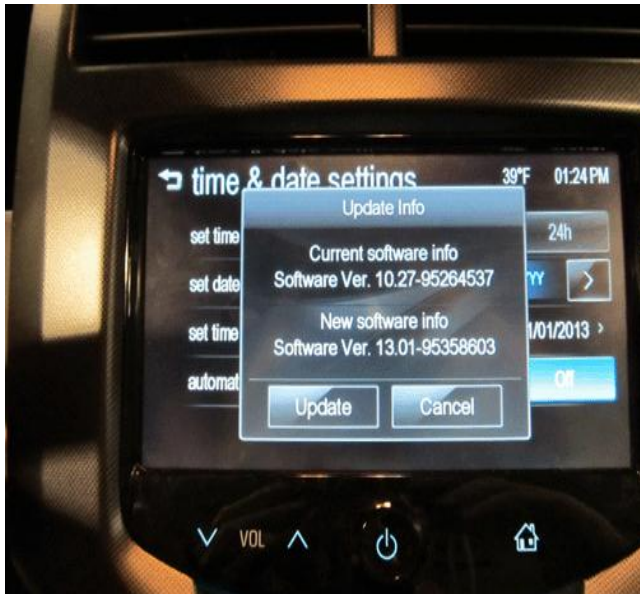
3286034

Note: If you still see the message “The following update file is Invalid SMD file,” the date has not been changed correctly on the radio.
