Service Bulletin

SUBJECT: Service Update for Inventory and Customer Vehicles
Turbo Vacuum Hose Routing - Inspect
Expires with Base Warranty

MODELS: 2014 Cadillac XTS
Equipped with 3.6L V6 Engine (LF3)

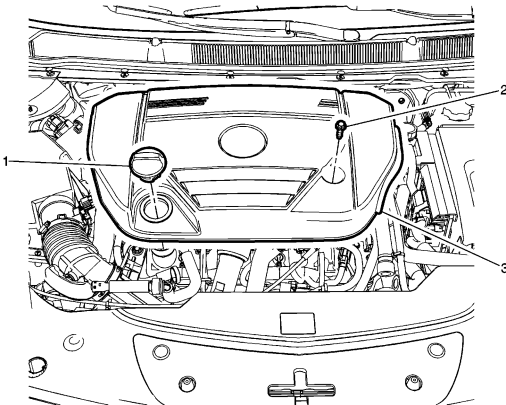
3330809

Note: Inspect the turbo charger wastegate actuator vacuum boost tube bundle for proper routing. In addition, inspect the condition of the tubing and clip attachments. Ensure tubing does NOT have any kinks or cuts. Replace damaged tubing or clip attachments.

2. Remove the intake manifold cover. Refer to *Intake Manifold Cover Replacement* in SI.

- If the turbo charger wastegate actuator vacuum boost tube bundle (1) is routed correctly, no further action is required. Install the intake manifold cover and front compartment front sight shield. Refer to *Intake Manifold Cover Replacement* and *Front Compartment Front Sight Shield Replacement* in SI.

- If the turbo charger wastegate actuator vacuum boost tube bundle (1) is NOT routed correctly, disconnect the tube bundle from the attachment points and re-route the tube bundle. Install the intake manifold cover and front compartment front sight shield AFTER completing the repair. Refer to *Intake Manifold Cover Replacement* and *Front Compartment Front Sight Shield Replacement* in SI. Refer to the following sections in this bulletin for information about how to correctly route the turbo charger wastegate actuator vacuum boost tube bundle:
 - Charge Air Bypass Valve Vacuum Tank Tube Routing and Connection Aids on Engine
 - Charge Air Bypass Valve Vacuum Tank Tube Routing and Connection Aids At Turbo Wastegate Regulator Solenoid
