Service Bulletin

Bulletin No.: PI0914B

Subject: MyLink Radio – Software Enhancement Update to Add BringGo and TuneIn Radio Applications and Siri Eyes Free – U.S. and Canada Only

Models: 2013 Chevrolet Sonic Built Prior to February 8, 2013
2013 Chevrolet Spark Built Prior to February 18, 2013
2013 Chevrolet Trax Built Prior to March 11, 2013
Equipped with Uplevel Radio (RPO UF7)

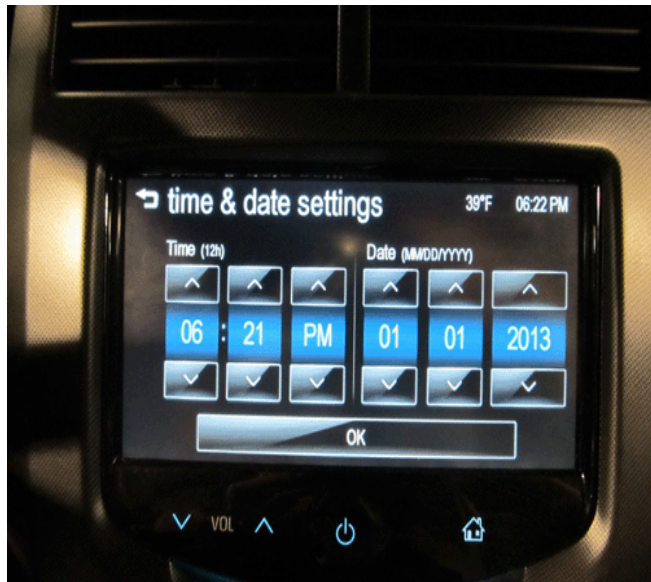
3286032

11. On the radio, go into settings and adjust the time 1 hour and change the date to 1/01/2013.
12. Return to the home screen and verify the date change before continuing.
13. If the date did not change, key-cycling the car may be necessary.
14. Insert the USB drive into the radio USB port in the vehicle.

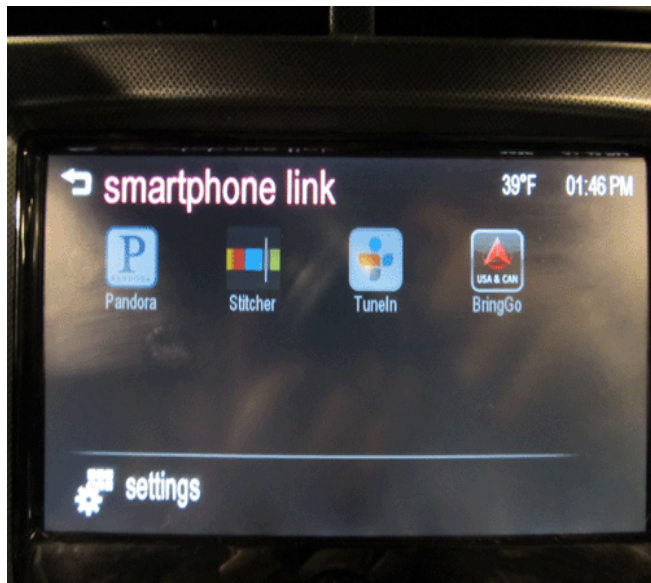
3286049

19. Select the Smartphone Link from the radio screen and verify BringGo and TuneIn Radio Application icons have been installed with this software update. Siri Eyes Free Software has also been added to this update but there is no icon.
