Service Bulletin

Bulletin No.: PI0914C

Subject: MyLink Radio – Software Enhancement Update to Add BringGo and TuneIn Radio Applications and Siri Eyes Free – U.S. and Canada Only

Models: 2013 Chevrolet Sonic Built Prior to February 8, 2013
2013 Chevrolet Spark Built Prior to February 18, 2013
2013 Chevrolet Trax Built Prior to March 11, 2013
Equipped with Uplevel Radio (RPO UF7)

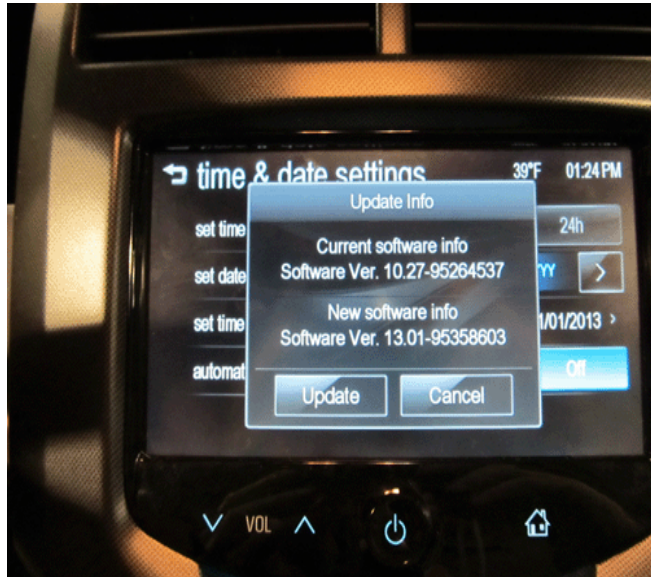
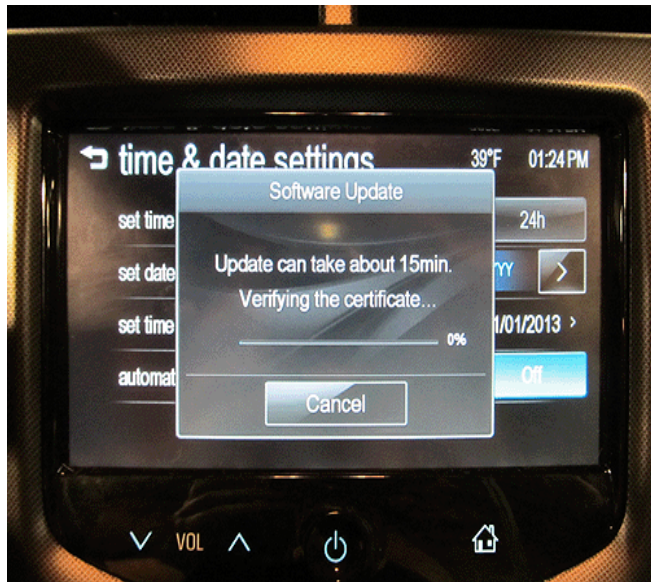
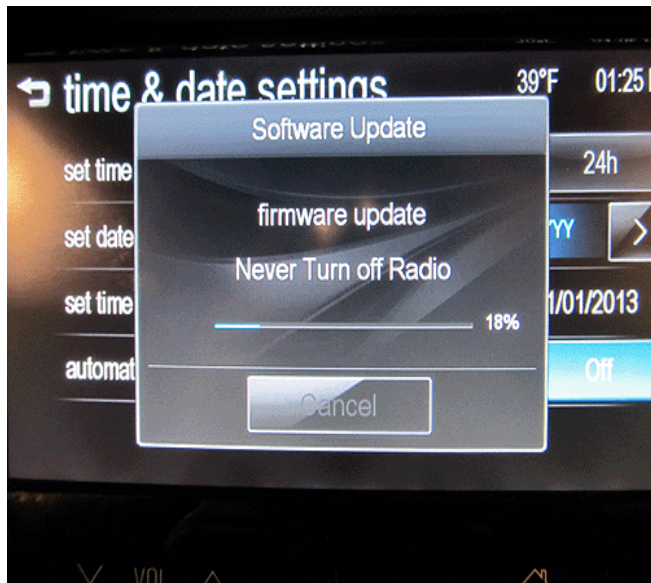
Note: If you still see the message “The following update file is Invalid SMD file,” the date has not been changed correctly on the radio.

11. On the radio, go into settings and adjust the time 1 hour and change the date to 1/01/2013.
12. Return to the home screen and verify the date change before continuing.
13. If the date did not change, key-cycling the car may be necessary.
14. Insert the USB drive into the radio USB port in the vehicle.

15. When the update info screen comes on, select UPDATE.

Note: If UPDATE is not selected within 10 seconds, the screen will disappear and the USB drive will have to be removed and inserted again to start the update process.
