Service Bulletin

Bulletin No.: PI0914D

Subject: Software Enhancement Update – MyLink Radio to Add Siri Eyes-Free, BringGo Navigation and TuneIn Global Internet Radio Applications (U.S. and Canada Only)

Models: 2013 Chevrolet Sonic Built Prior to February 8, 2013
2013 Chevrolet Spark Built Prior to February 18, 2013
2013 Chevrolet Trax Built Prior to March 11, 2013
Equipped with Uplevel Radio (RPO UF7)

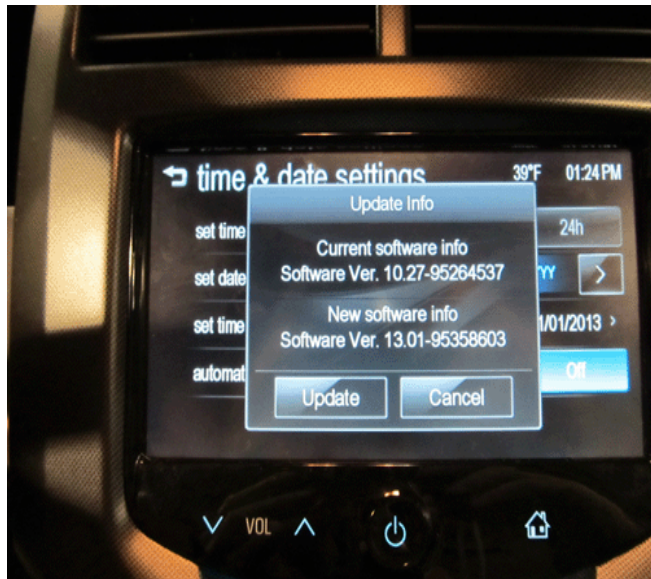
3286034

Note: If you still see the message “The following update file is Invalid SMD file,” the date has not been changed correctly on the radio.

11. On the radio, go into settings and adjust the time 1 hour and change the date to 1/01/2013.
12. Return to the home screen and verify the date change before continuing.
13. If the date did not change, key-cycling the car may be necessary.
14. Insert the USB drive into the radio USB port in the vehicle.
