# Service Bulletin

Bulletin No.: PI0916B

**Subject:** Floor/Carpet Wet at Front Passenger Side Under Dash, or at Any Front/Rear Footwell Area

**Models:** 2011-2013 Chevrolet Caprice PPV

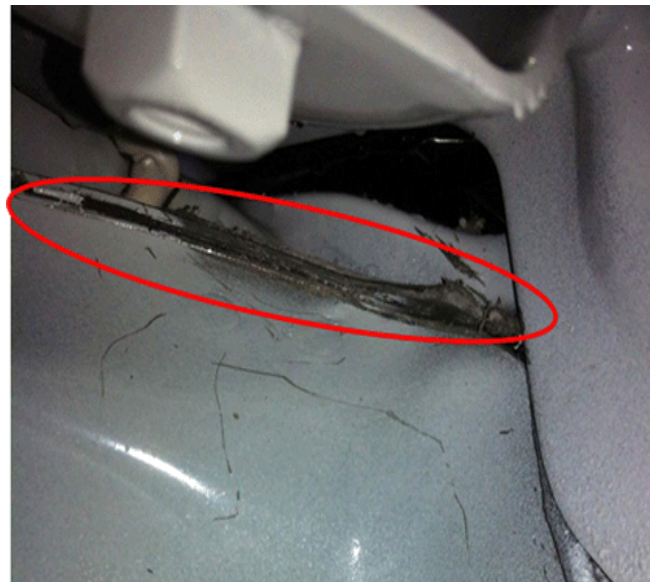
3655073

5. Once leak is confirmed, use a scraper to remove excess sealer patch material to expose the plenum seam edge. Only remove enough patch material to expose the seam. The graphic below show the exposed seam edge after removing the sealer patch.
