Service Bulletin

Bulletin No.: PI0929

Date: March, 2013

Subject: MyLink Radio – XM Inoperable, Service Camera Message On, No Bluetooth Function – GMNA Only

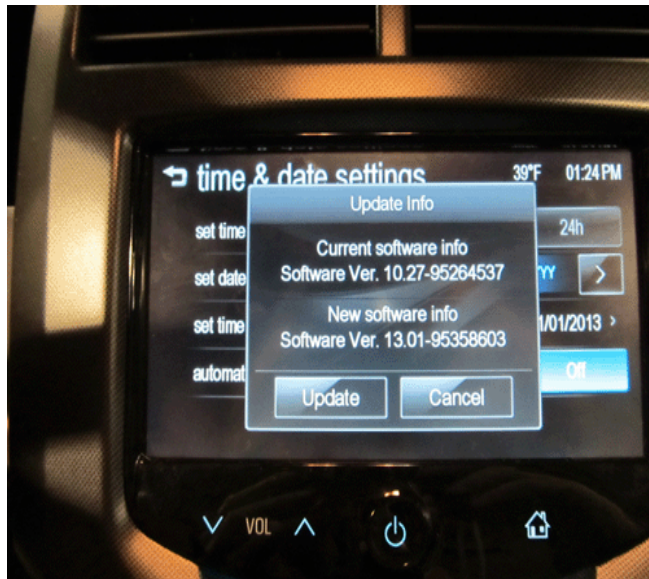
3286034

Note: If you still see the message "The following update file is Invalid SMD file," the date has not been changed correctly on the radio.

11. On the radio, go into settings and adjust the time 1 hour and change the date to 1/01/2013.
12. Return to the home screen and verify the date change before continuing.
13. If the date did not change, key-cycling the car may be necessary.
14. Insert the USB drive into the radio USB port in the vehicle.
