Service Bulletin

Bulletin No.: PI1137

Subject: Temperature and Blower Speed Knobs Difficult to Rotate and/or Make a Clicking Noise

Models: 2014 Chevrolet Corvette
Condition/Concern

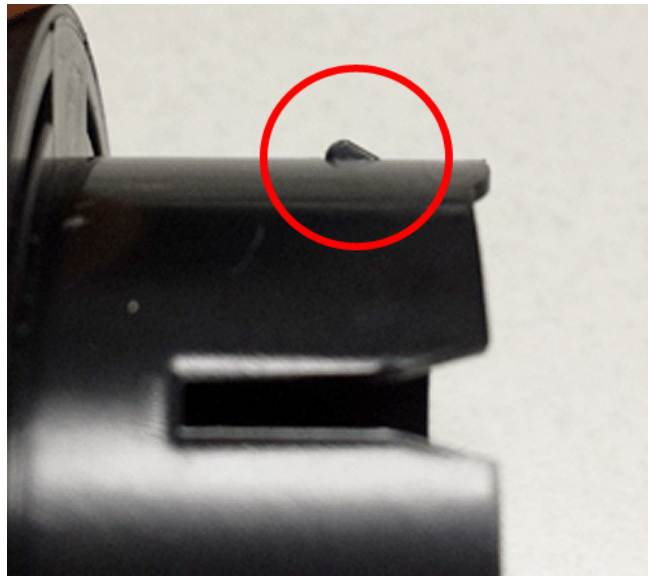
Some customers may comment that the knobs are difficult to turn and/or make a clicking noise when attempting to adjust the blower speed or the interior temperature on the HVAC control.

Technicians should remove a portion of the 3 detents on the control knobs following the procedure below:

1. Gently remove the HVAC control knobs.

2. With a sharp tool, remove the red portion of each detent as shown above.

Important: Be sure not to remove too much or all of the detent. The HVAC control knob will not seat and be loose if too much material is removed.
