SERVICE BULLETIN

APPLICABILITY: 2010-2013 Legacy and Outback Models **NUMBER:** 07-72-13
SUBJECT: Sunroof Does Not Open or Close Properly **DATE:** 01-29-13
 Popping or Slamming Sound When Glass Lowers
 Prior To Opening

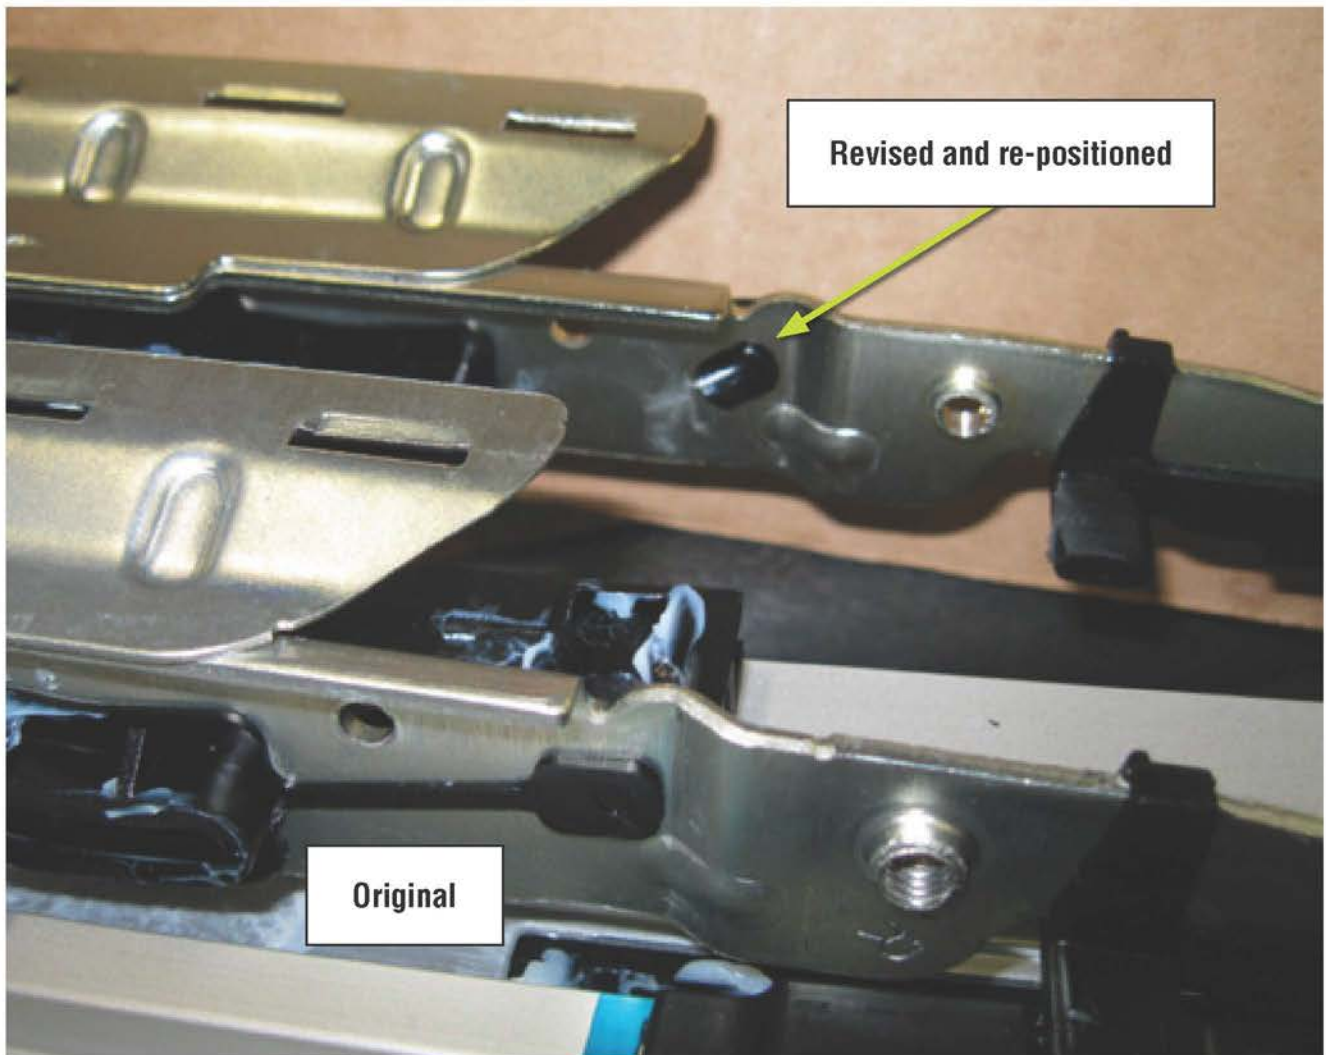
- Verify the customer's concern(s) as reported.
- Inspect the sunroof side rails and wedge cap areas closely for damage. If any damage is confirmed, remove the sunroof assembly from the vehicle following the procedure in the applicable Service Manual. No further inspection is required. Replacement of both cable assemblies and the rail assembly will be required to repair the vehicle.
- If the sunroof makes a sound when it is opening but no damage as outlined above is found:
 - o Close the sunroof completely.
 - o Confirm that the glass panel extends above the roofline by 1mm or less as shown by "L" in the illustration below.
 - o If the glass panel is not within the specified 1mm of flush, open the sunshade, remove the trim covers then loosen the four glass panel mounting bolts. Shim the glass panel assembly as necessary to achieve the desired measurement.

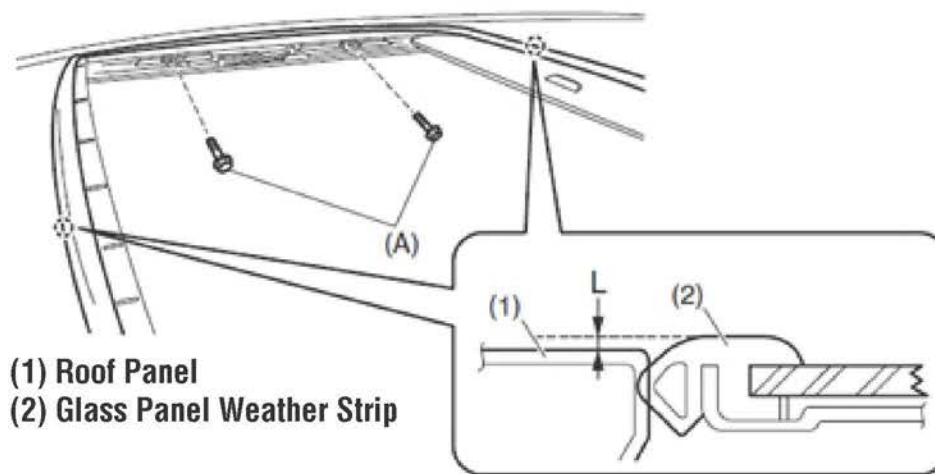
- Open the sunroof to the point where the rear edge of the glass is fully dropped down, just before it retracts under the roof panel.
 - o Determine the center point of the back edge of the glass panel by measuring from the outside edges in toward the middle from each side.
 - o Measure the distance between the top outside edge of the roof opening flange and the glass panel as shown in the photo below.
