**SUBARU.****QUALITY DRIVEN® SERVICE****SERVICE BULLETIN**

APPLICABILITY: 2013MY Legacy and Outback 2.5L Models
 2012-13MY Impreza 2.0L Models
 2013MY XV Crosstrek
 2011-2014MY Forester NA Models Only
 2013MY BRZ

NUMBER: 11-130-13
DATE: 04/05/13

SUBJECT: Difficulty Starting, Rough Idle, Cam Position or Misfire DTCs
 P0340, P0341, P0345, P0346, P0365, P0366, P0390, P0391,
 P0301, P0302, P0303 or P0304

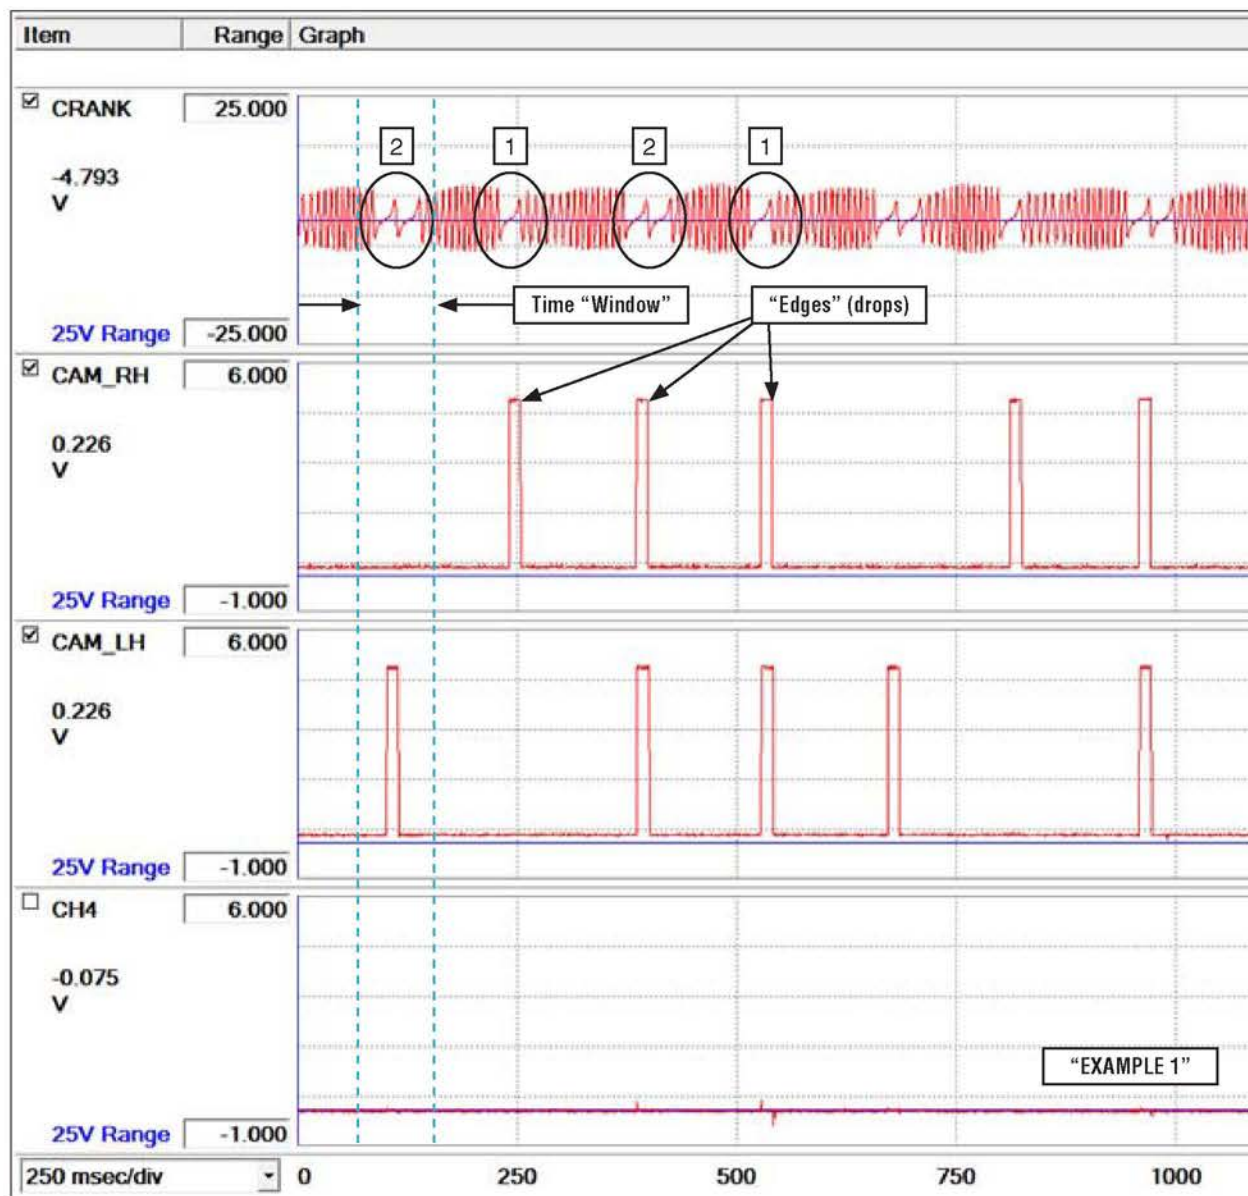
Looking at the crank signal on page 4, you will see the difference between what we will call “1's” (a single spike) and “2's” (a double spike). This helps establish the engine's firing order and what the corresponding cam sensor data should look like. The ECM looks for the “Edges” of the cam position sensor voltage drops to be within specified time “Window” parameters. The chart below Example 1 on the next page will help bring this all together. (Range was set to 250 msec / div. so the crank signal would be easier to understand here.)

Engine Firing Order	#1	#3	#2	#4
Crank Signal ("1" or "2"?)	"1"	"2"	"1"	"2"
Is Cam Signal Edge Within Window RH?	Yes	No	Yes	Yes
Is Cam Signal Edge Within Window LH?	Yes	Yes	No	Yes

Using the chart above and comparing it to **Example 1**, it can be determined the first cylinder shown in the screen shot is #3 because the crank signal is a "2" and there is an edge signal within the window on the LH but not the RH cam sensor. Next cylinder in the firing order would be #2 as the crank position signal is a "1" and there is an edge signal in the window for the RH but not for the LH, and so on...

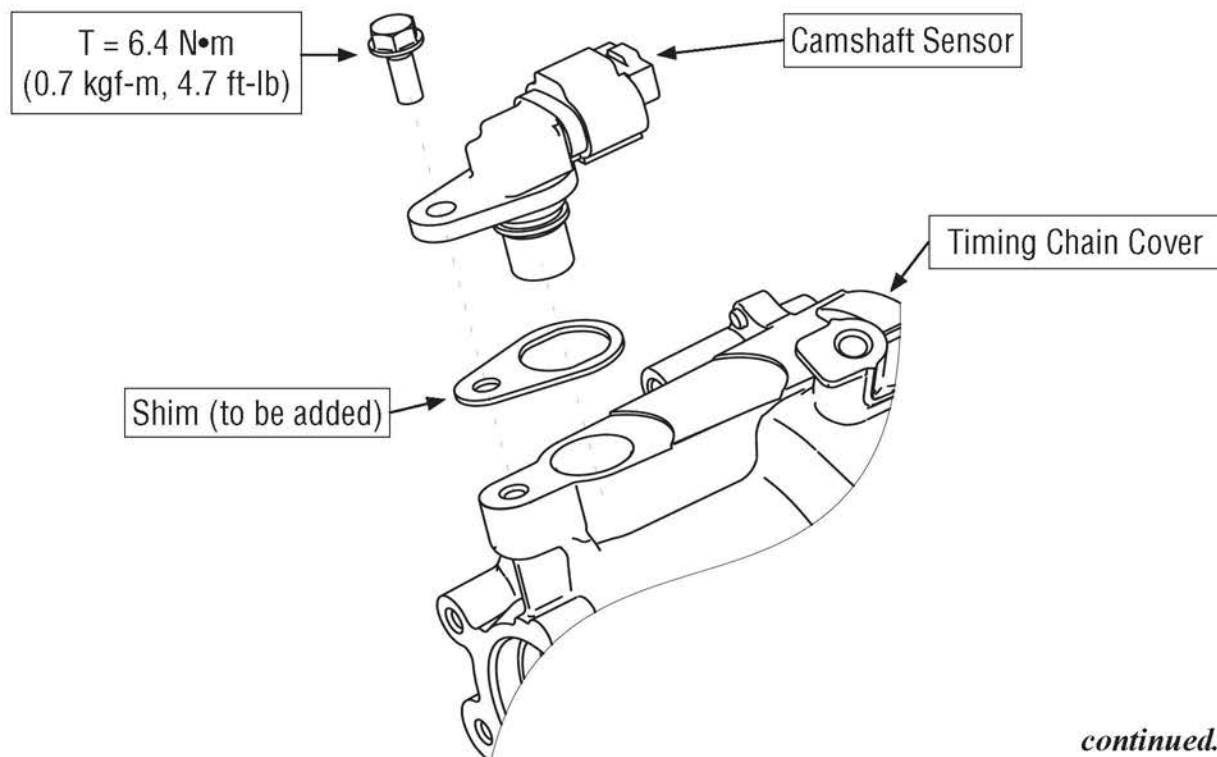
A = Top of timing chain cover to camshaft position sensor plate

B = Camshaft position sensor mating surface to the bottom of the sensor

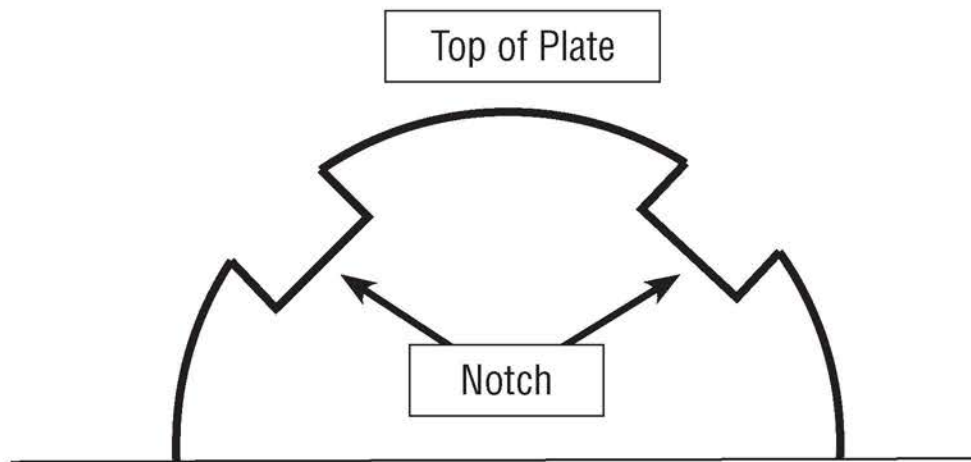
NOTE: When measuring “A”, make sure you are measuring to the outside diameter or “top” of the sensor plate and not to the bottom of a notch as shown below. Be sure to record all measurements.

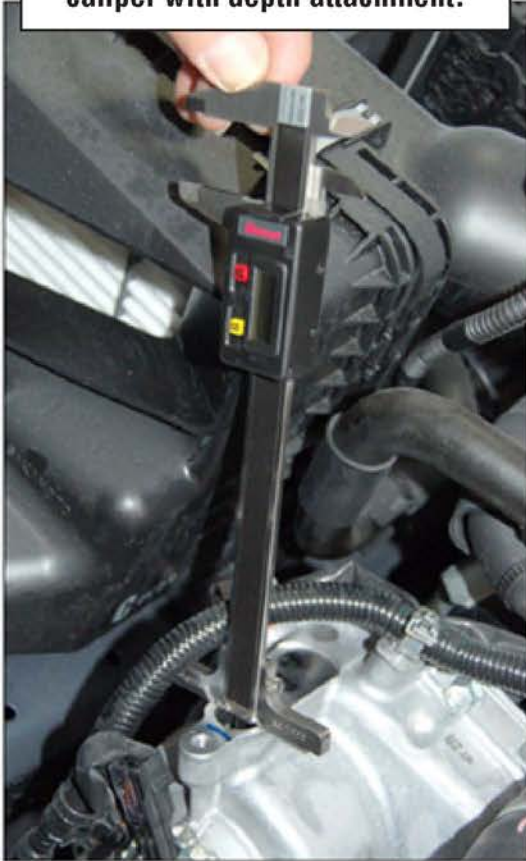
Measurement taken using digital caliper with depth attachment.

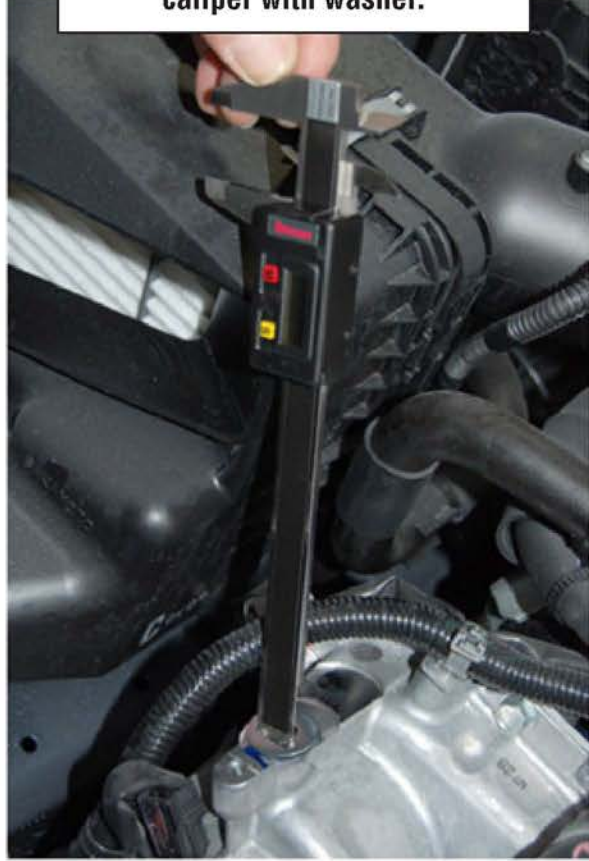
Measurement taken using digital caliper with washer.

IMPORTANT: When using the flat washer, make sure the washer is fully seated on the machined surfaces of the timing cover or your measurements will not be accurate.

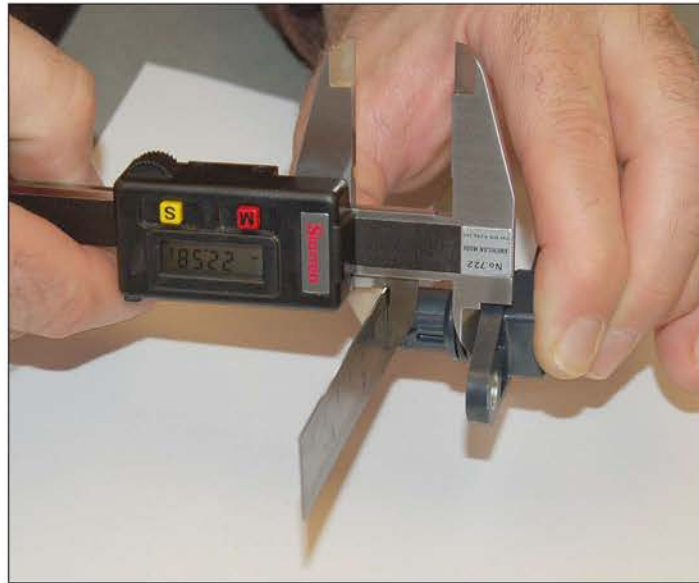
When taking measurement “B”, use a flat steel ruler or equivalent along with the digital caliper.

7. Measure the distance between the camshaft position sensor mounting surface and the bottom of the sensor as shown above.
