TECHNICAL BULLETIN
LTB00557NAS2
23 JAN 2014

Knock Sound From Front Suspension

Range Rover (LG)

Model Year: 2013 Onwards

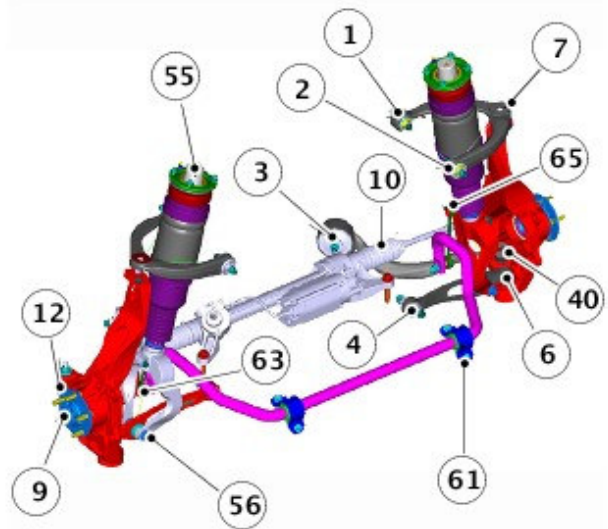
E156340

Front Suspension Knock Diagnostic Test (refer to step 1)

3. Disconnect electrical connectors from front Adaptive Damping System shock absorbers.
