TECHNICAL BULLETIN
LTB00625NAS1
28 APR 2014

SECTION: 204-00

'Knock' Sound From Front Suspension

Range Rover Sport (LW)

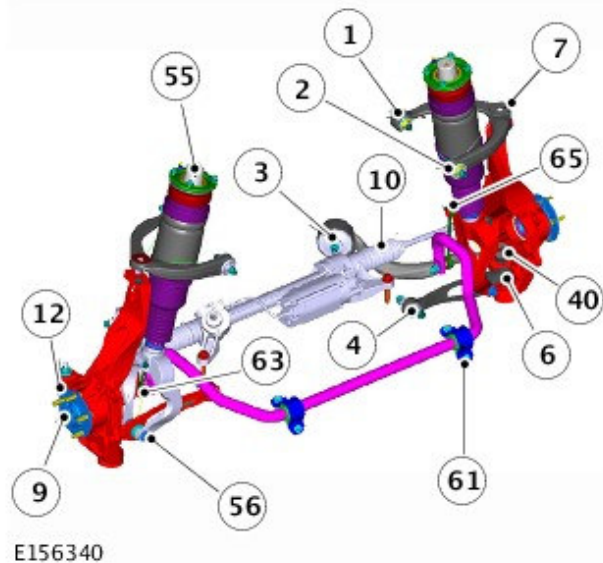
Front Suspension Knock Diagnostic Test (refer to step 1).

- 2. NOTE: disconnecting the Dynamic Response system fuse is not recommended to help in diagnosing front suspension knock as it will change the forcing into the suspension.**

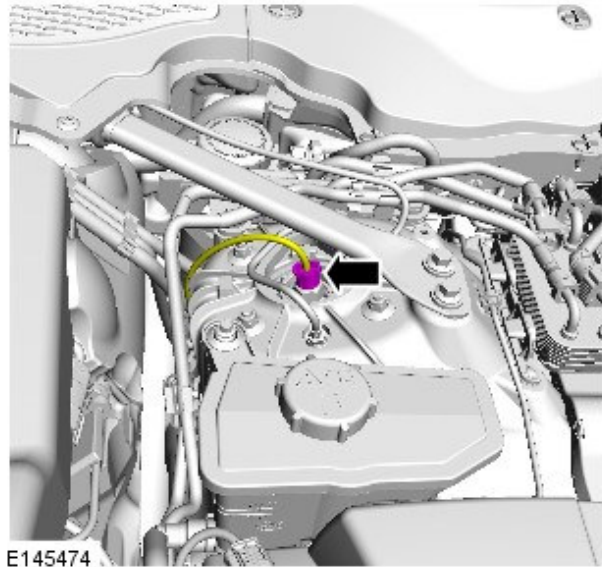
- 3. Disconnect electrical connectors from both front Adaptive Damping System shock absorbers.**
