TECH TIMES

The Professional Publication for Kia Dealership Technicians & Service Staff

Volume 17, Issue 4

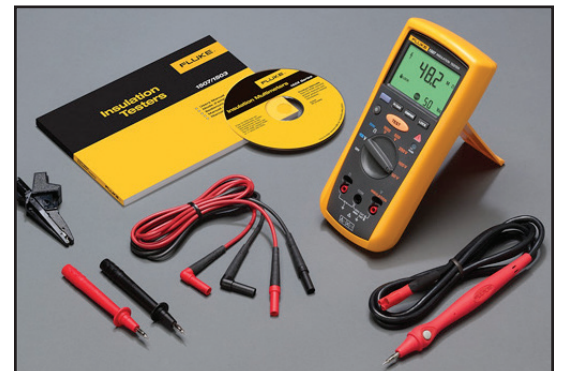
Turn meter on and move mode selector switch on DVOM to DC 500 volts. Place the red test lead end on the U-V-W pin connector one pin at a time and hold the test button down for 1 minute while monitoring the insulation

resistance indicated in large numbers on meter. When performing this test the meter sends 500 volts through the coil windings and detects current leakage. You should have a reading of 10 mega ohms or higher for each pin tested. Readings below 10 mega ohms or OL (out of limits) indicate a bad Drive Motor or HSG insulation resistance in the motor windings and require replacement of either the Drive Motor or Hybrid Starter Generator.

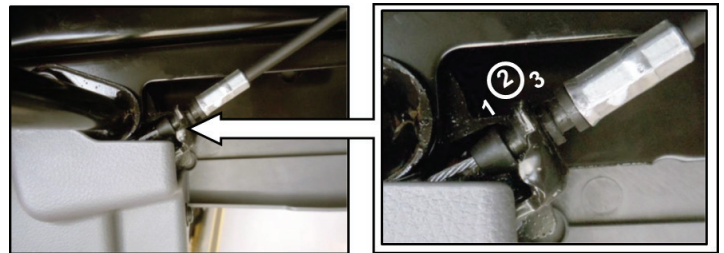
2. Check the current position for the seat release cable adjuster. The default setting from the factory is in slot two (2).

3. If more tension is required to operate the release mechanism, remove the cable adjuster from the default slot and place it in slot one (1).
4. If there is excess cable tension in the mechanism, remove the cable adjuster from the default slot and place it in slot three (3).
5. Operate the seat release handle to make sure the seat will tumble forward.
6. Repeat the steps above on the opposite side second row seat, if necessary.

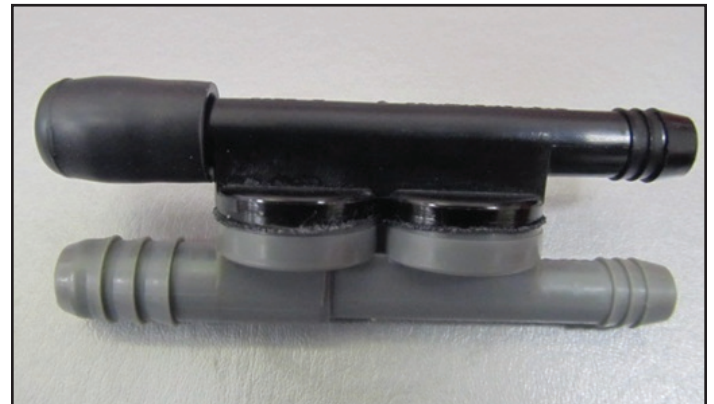
Air flow operation test: The intensifier has two gray ports (one larger, one smaller) and one open black port. You should be able to lightly blow through the larger gray port

and feel air exiting the smaller gray port. There should be a resistance caused by the venturi. Blowing through the larger gray port, air should not exit the open black port. Pulling a vacuum on the larger gray port should pull air through the open black port.

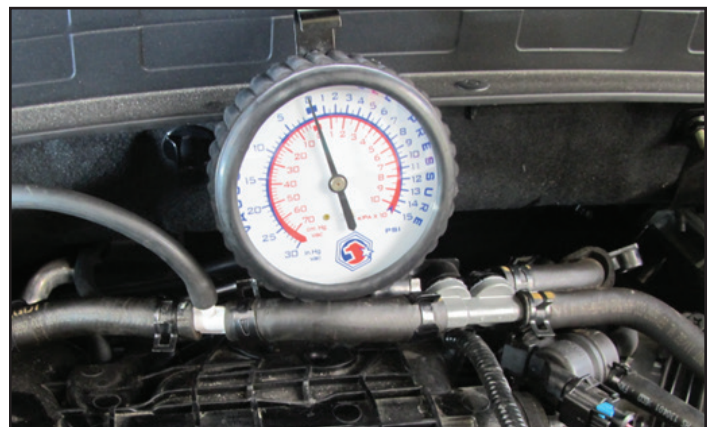
Vacuum test: a vacuum gauge can be installed in the manifold vacuum line going to the intensifier. After starting the engine, record the vacuum reading. Move the gauge to the vacuum line going into the booster and record the reading. The vacuum reading should be the same or higher at the booster as it is at the intake manifold.
