MODEL
Sorento (XMa)
2011-2013MY

NUMBER
093 (REV 3, 10/31/2014)

TECHNICAL SERVICE BULLETIN

SUBJECT: SECOND ROW SEAT INOPERATIVE OR DIFFICULT TO RELEASE

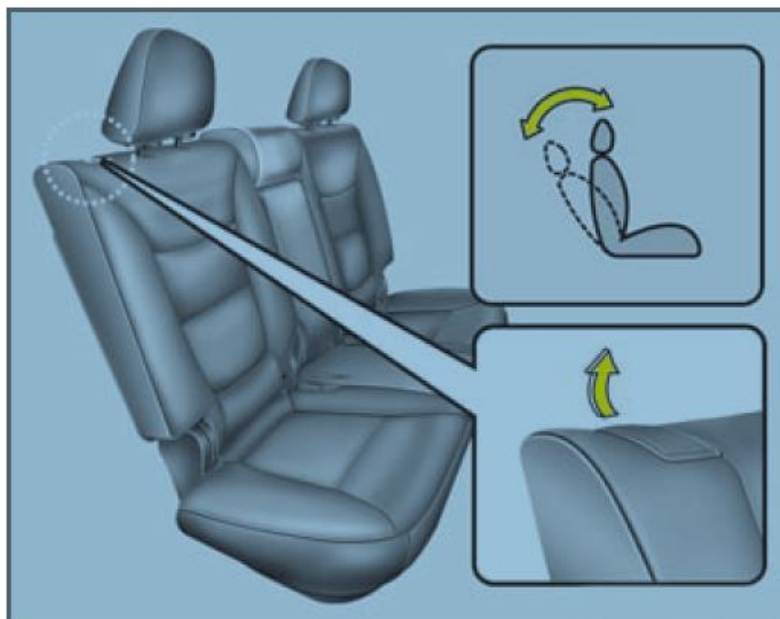
This bulletin provides information related to some 2011-2013MY Sorento (XMa) vehicles, produced from October 26, 2009 to November 5, 2012, which may exhibit a concern related to the second row seats being inoperative or difficult to release. It is important to note that some amount of effort is required to fold the 2nd row seats. To correct this condition, follow the service procedure outlined in this TSB.
