| REFERENCE: | Nova Bus Manuals |
| RS N°: | MQR 7621-1030 |

| SUBJECT: | Right wall structure with 1:6 ramp |
| JUSTIFICATION: | Vertical beam might crack above front door, second post capping. |

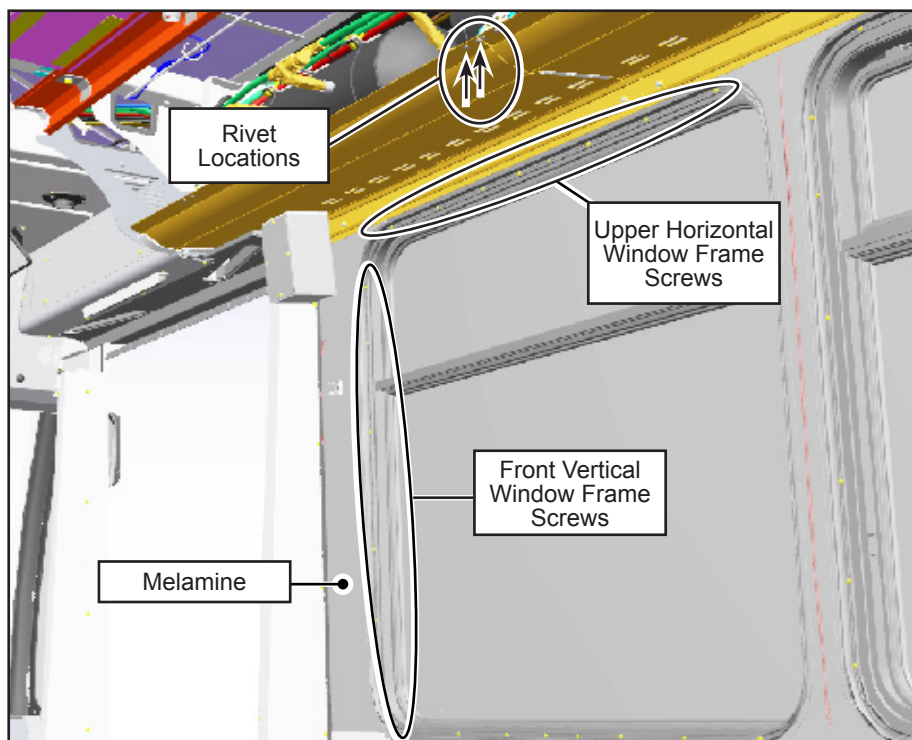
Figure 5 - Drill Out the Two Rivets and Remove Window Frame Screws

- 1.9. Purge the air system, then disconnect the two pneumatic hoses and the connector at the emergency valve.
- 1.10. Remove the emergency valve assembly.
- 1.11. Disconnect the harness and remove the side sign with the help of an assistant.
- 1.12. Remove the window frame screws from the upper horizontal and the front vertical frame portions in order to facilitate the baselight and melamine removal.
- 1.13. To remove the first baselight, start by drilling out the two rivets at the joint of the second baselight. See Figure 5.

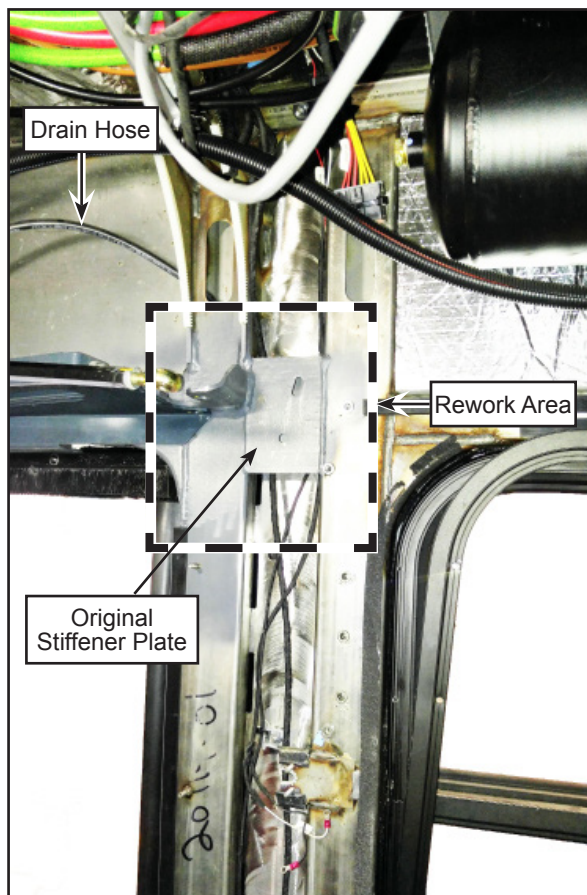
Figure 7 - Secure All Hoses and Wires Away From the Rework Area

- 1.16. Remove the wires and the pneumatic hoses from the wall structure, including the pneumatic drain hose into the vertical tube (see Figure 7) and attach them temporarily away from the area to be reworked. Remove and keep the u-channel edge protector.

- 1.18. With a cut-off wheel, remove the original stiffener plate between the two vertical tubes, see Figure 7. This plate will be replaced by N71120, see Figure 8.
