LA 45 COMPO: Headlight Mount Rework

Property name and top bus number: LA 45CLFW 218000, 269000

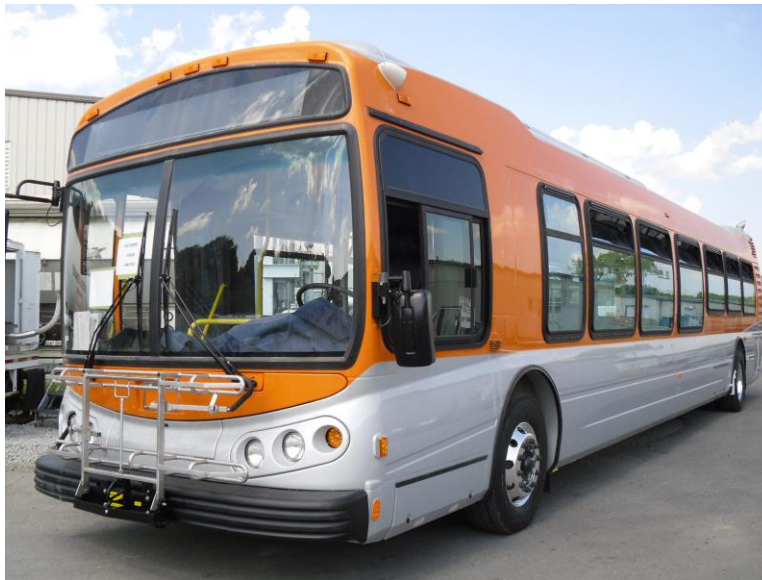
Issue: Headlight bulb doesn't fit the mounting bracket (bucket) correctly.

Reason/ cause: Under investigation.

Solution: Modify the headlight mounting bracket per this work instruction.
