# Corrosion Inspection Behind the Lower Cove Panels

**Property and Top Bus Number:** NJT 305000

**Issue:** Corrosion inspection behind the lower cove panels

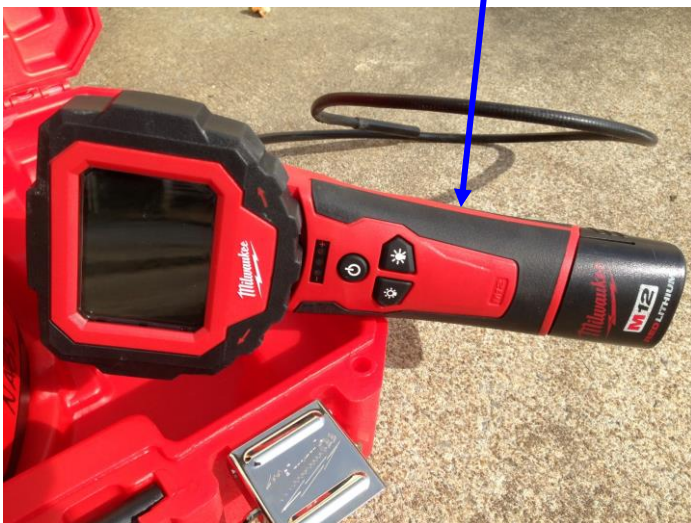
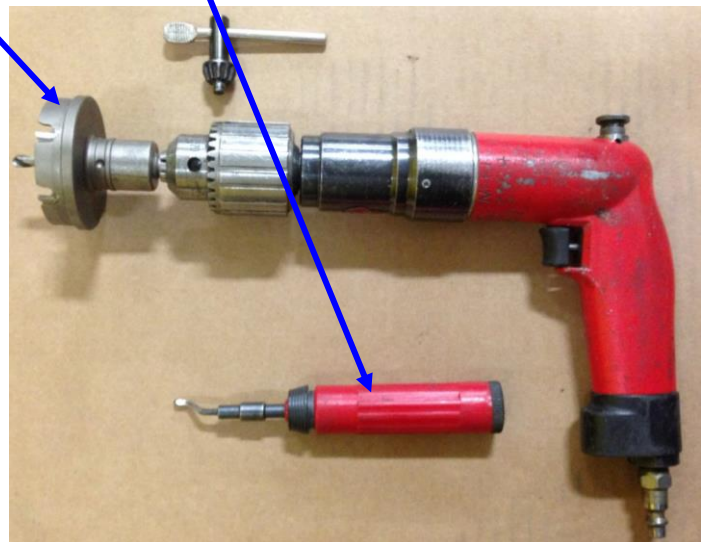
**Reason / cause:** This part of the structure is covered with sheet metal panels (dust panels) and access holes are needed for inspection of this area.

**Solution:** Drill access holes and inspect structure per this work instruction.
