Release 1: This document supersedes previous revisions.
 Nov 10, 2014 Added desired bulb position and MUX software verification.

BITZER COMPRESSOR REMOTE PRESSURE SENSORS AND SWITCH

Prevost vehicles

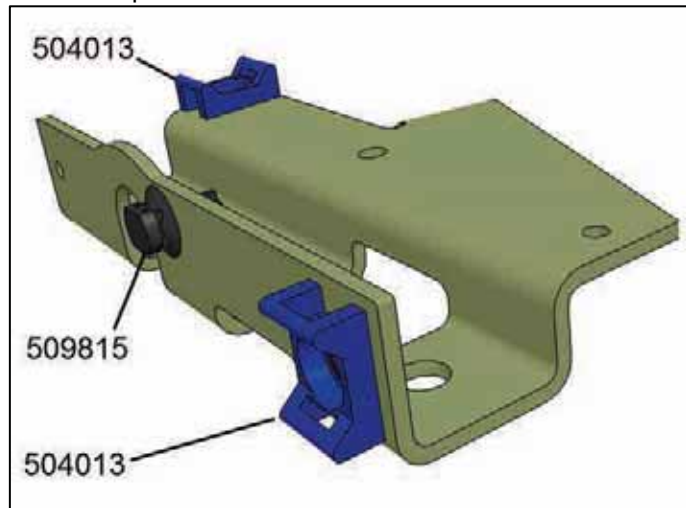
Figure 12

Place cable tie bases #504013 with Stainless Steel dome pop rivets #504379. (Fig. 12)

Add one #509815 cable tie base with christmas tree in the hole located in the center of the cable support.

Do not assemble with aluminum rivets.

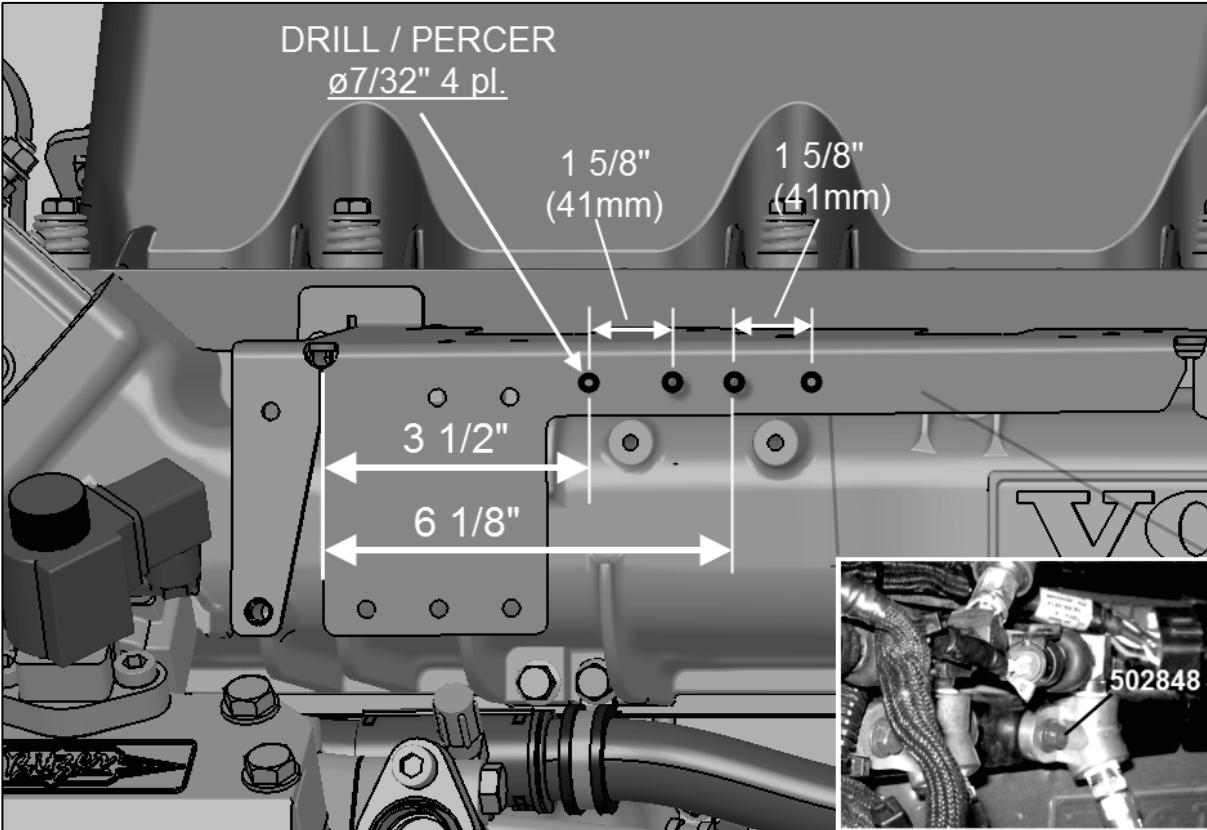
Figure 16: Drilling on the cable support

- 2.10. On certain vehicles the cable support will not have reference holes.
Four (4) new holes will need to be drilled. Use dimensions provided below. (Fig. 16)

Secure fitting assemblies with thread cutting screws 502848 (Fig 16)

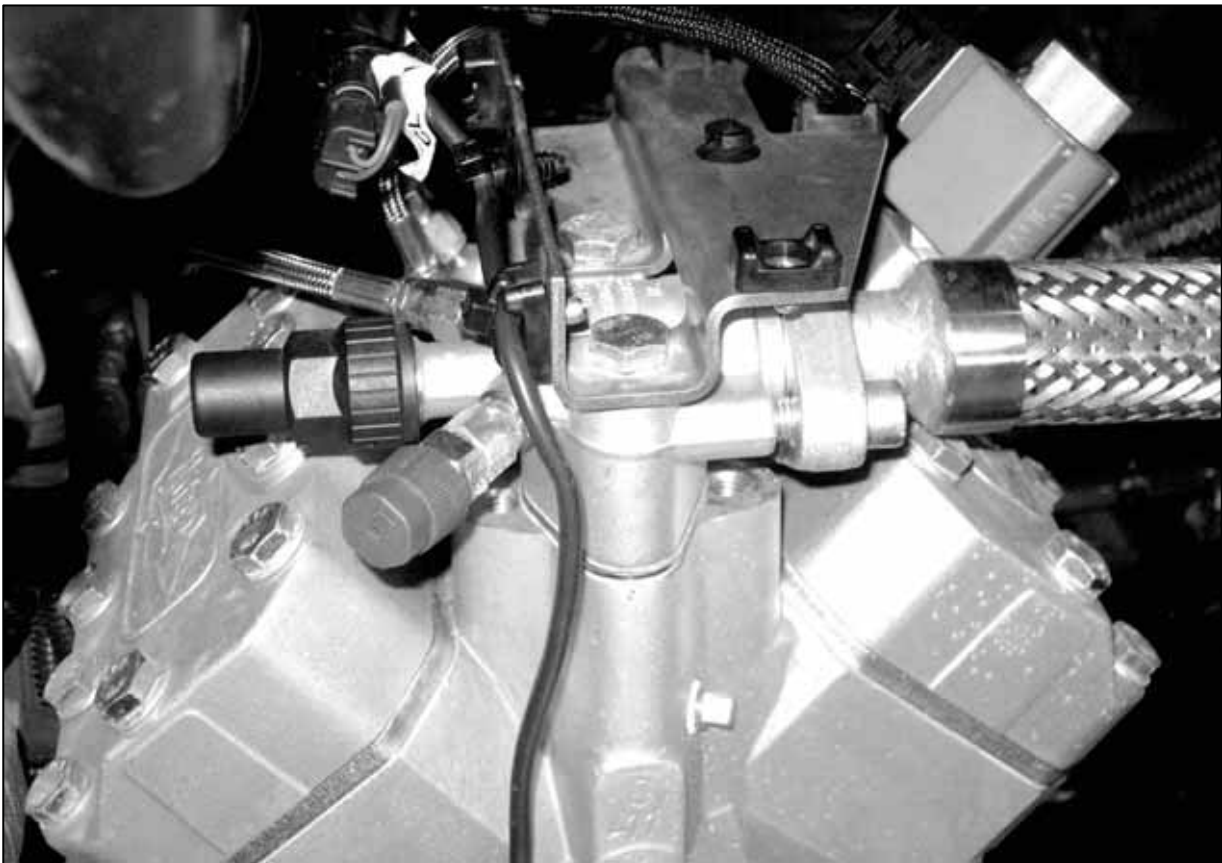
Figure 17 Rear view

- 2.11.1. Install new harness **069206** by connecting **L199** to the unloader.
- 2.11.2. Secure the cable on the cable tie mounts. **Until 069099 is available as a service part, route to avoid sharp edges.** (Fig. 17, 18).
- 2.11.3. Connect **So9** to the clutch connector.
- 2.11.4. Install one swivel cable tie base **504751** on the flexible section of the oil fill tube. (Fig. 18). Secure clutch connector in an orientation that allows easy disconnection. Tie excess length of cable by making loops. (Fig. 18)

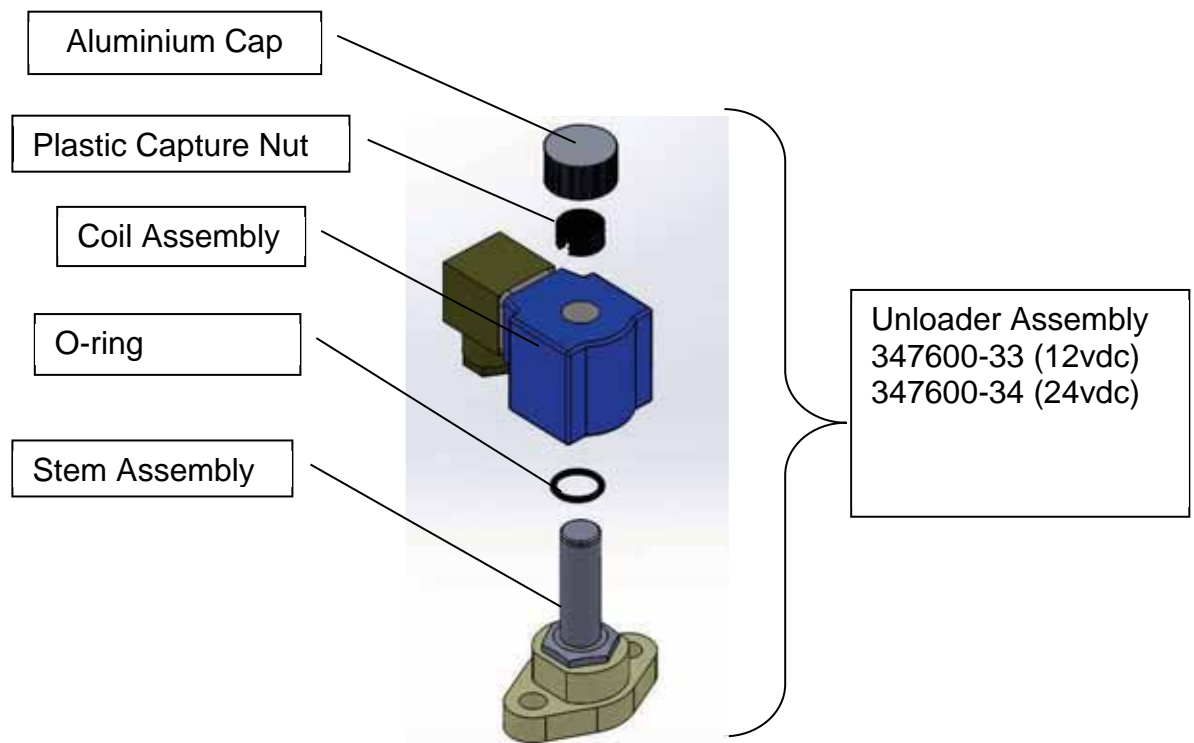
Due to a number of claims relating to unloader caps coming loose, BITZER US, Inc. has developed a procedure for reliably securing the unloader cap to the unloader coil and stem assembly.

Below is typically unloader coil assembly and parts;

- If the cap comes loose from the unloader assembly it will be necessary to replace to maintain good operating order with the unloader.
 - The replacement part number for new cap components is 375068-02. This will include a new aluminum cap, capture nut and o-ring.

- All 3 parts should be replaced during the exchange
1. Remove the existing capture nut, coil and o-ring
 2. Install a new o-ring over the stem assembly
