PREVOST

**WARRANTY
BULLETIN**

WB14-47B

DATE :	OCTOBER 2014	SECTION :	04 - Exhaust
EXPIRATION:	OCTOBER 2016		
SUBJECT :	UREA DOSING SYSTEM UPDATE - X AND H SERIES

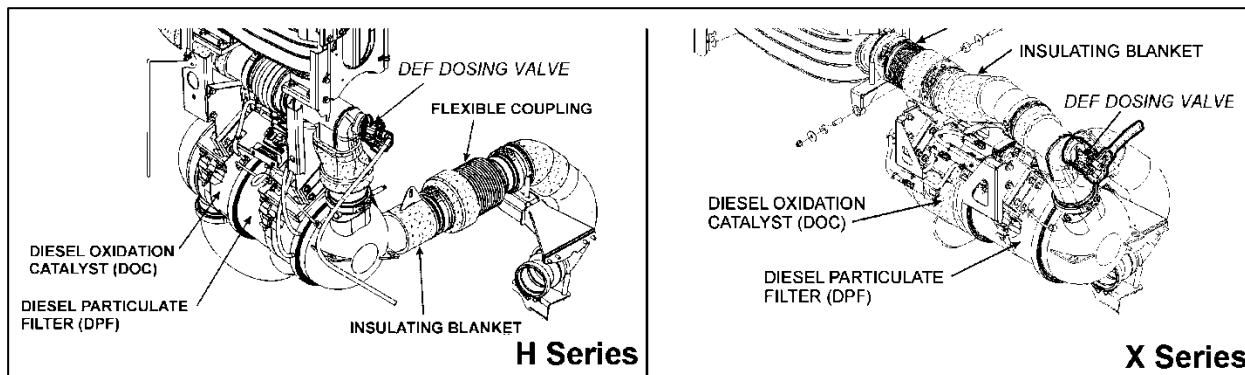
Figure 3: Exhaust System Components Overview

These hardware and software improvements aim to reduce the occurrence of clogging and shorting of the Urea Dosing Valve.

As an additional improvement, replace the urea dosing valve by an improved design.

The procedure will guide you through the replacement of the *urea dosing valve*.
