Service Bulletin

Bulletin No.: 10-06-01-008L

Subject: Engine Oil Consumption on Aluminum Block/Iron Block Engines with Active Fuel Management (AFM) (Install AFM Oil Deflector and Clean Carbon from Cylinder and/or Install Updated Valve Cover)

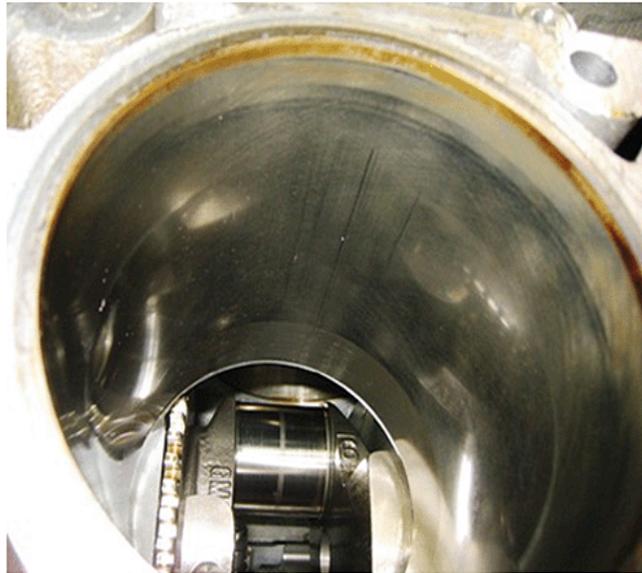
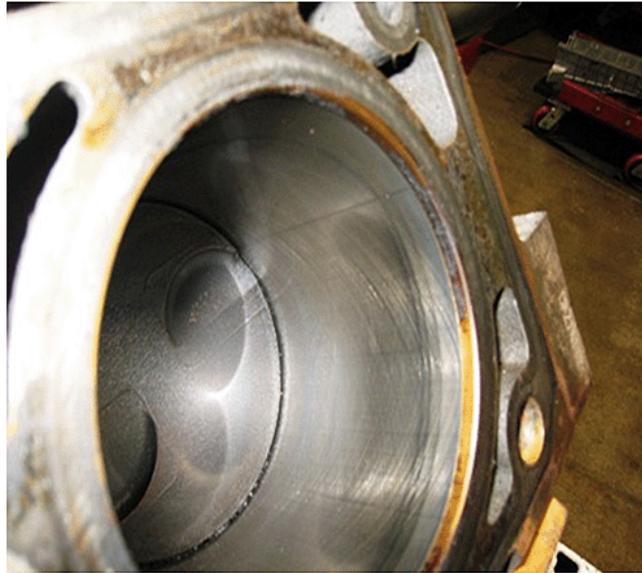
2596640

Important: Some minor scratches may be noticed on the cylinder walls during piston and ring replacement. If the scratch cannot be felt when running your finger nail over it, the scratch is considered normal wear and the block or engine should not be replaced.

Note: It is not necessary to hone or deglaze the cylinder walls. Honing may induce unnecessary cylinder wall and / or piston ring damage if it is done incorrectly and/or not cleaned thoroughly. Cylinder walls should be cleaned thoroughly with brake cleaner before installation of the new pistons and rings. Numerous engines replaced for oil consumption have been inspected. The cross hatch has been consistently good and is in specification. As a result, it should not be necessary to measure the cylinders if they pass the visual inspection.

Note: After the piston/ring replacement, it will take 2000-3000 miles for the new rings to seat. Adequate break time is necessary prior to rechecking the oil consumption level.
