# Service Bulletin

Bulletin No.: PI1199A

## PRELIMINARY INFORMATION

**Subject:** Engine Cranks But Does Not Start, Engine Cranks With Loud Backfire, Engine Will Start and Stall, Engine Cranks with Hissing Noise from Tailpipe or Buzz, Pop, Rattle or Whistle Noises Occur

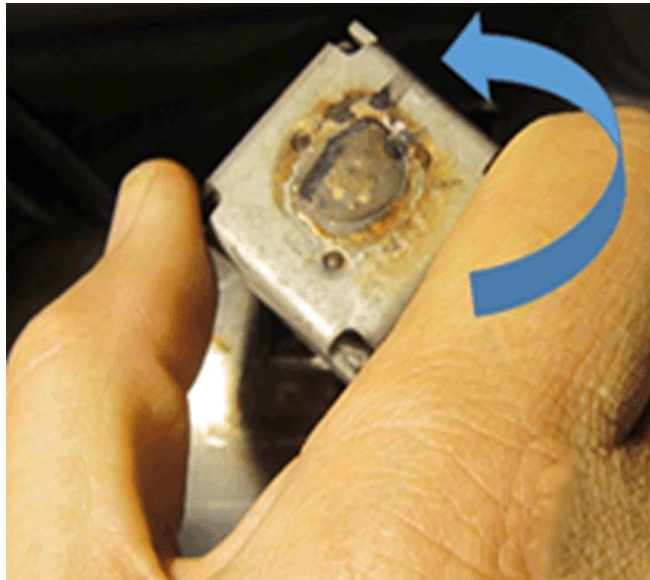
3768219

Some Customers may comment on a buzz, pop (oil canning) or rattle noise coming from the exhaust system during warmer ambient temperatures and when the engine is at normal operating temperature, under different driving conditions.

**For a buzz or pop (oil canning) noise, Go to Step #1.**

2. While holding the PEV in the rotated position, install a 1/4 in x 20 x 2 in steel bolt, nut, lock washer and two large standard 1/4 in x 1 in outside diameter washers (body washer) as shown.
3. Operate the vehicle during warmer ambient temperatures **and** when the engine is at normal operating temperature under different driving conditions and verify that the buzz, and/or pop (oil canning) noise is coming from the exhaust system.
  - ⇒ If the buzz, and/or pop (oil canning) noise is coming from the exhaust system during the testing, replace the exhaust system. Refer to Exhaust Muffler with Resonator, Exhaust, and Tail Pipe Replacement in SI.
  - ⇒ If the buzz, and/or pop (oil canning) noise is not coming from the exhaust system during the testing, refer to Symptoms — Engine Mechanical in SI.
