**Document ID:** IK0800264

**Title:** Erratic rear lighting, water pump and back up alarm in combination

**Applies To:** eStar production

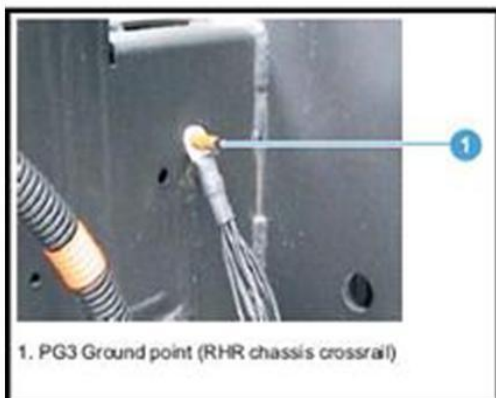
- Locate the PG3 ground point located on the right hand rear of the chassis crossrail in front of the inverter and the high voltage inverter leads. It is best viewed looking upward toward the outer framerail from in front of the inverter. Use a long screwdriver or similar object to test the tightness of the ground by attempting to spin it.

If the ground is loose use the appropriate tools to tighten the nut on the stud. Recheck for correct component operation.
